RE: Fairbury Asbestos Inspection Report  
Property of Tina Borch  
120 W 3<sup>rd</sup> Street  
Fairbury, NE 68352  
40.133900° N, 97.186505° W

## Building Asbestos Inspection Report

Inspection Date: 2/27/2023

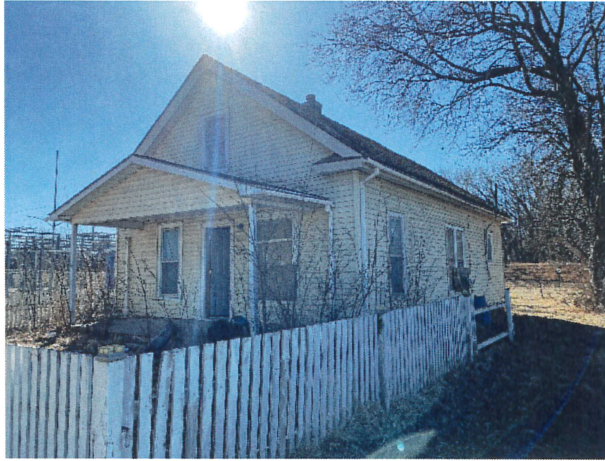
Northwest exterior elevation  
viewing southeast

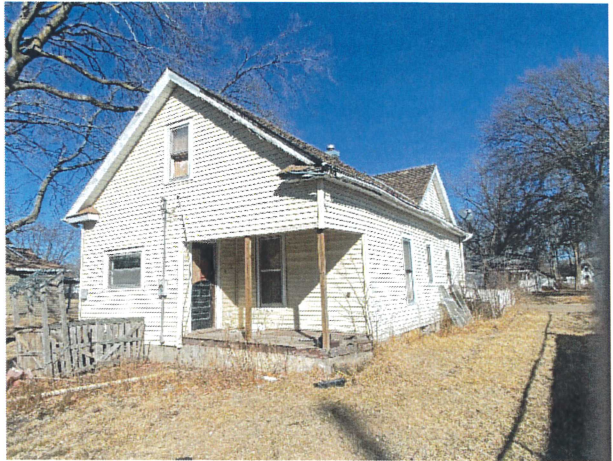
Southeast exterior elevation  
viewing northwest

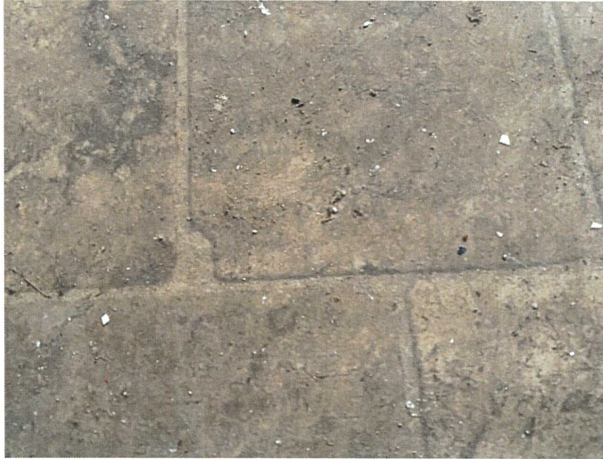
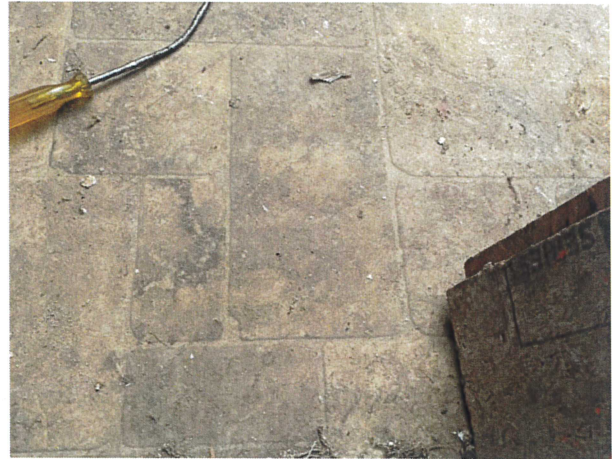
| Sample Date | Sample ID | Description | Location | Asbestos Result <sup>2</sup> | Asbestos Type | ACM Category | Friable Y/N | Quantity |
|---|---|---|---|---|---|---|---|---|
| 2/27/2023 | FAI-120-270223-001, 002, 003 | Tan Stone Vinyl Sheet Flooring | Interior, Kitchen (top layer) | None Detected | N/A | N/A | N | 144 sf |

FAI-120-270223-001, 002, 003  
None Detected, Tan Stone Vinyl  
Sheet Flooring

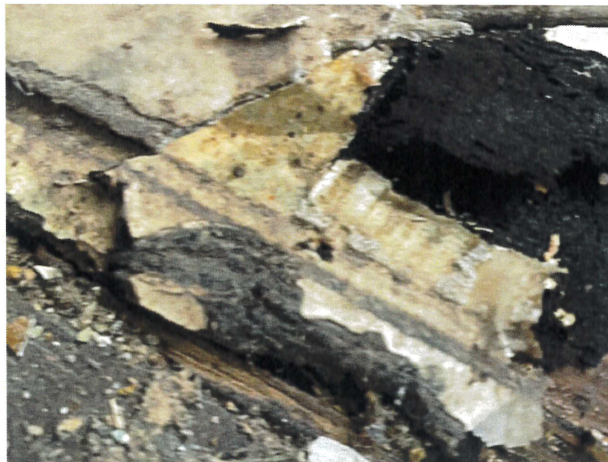
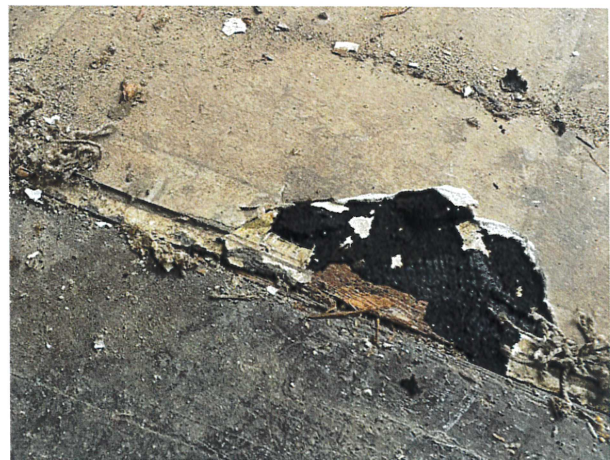
| Sample Date | Sample ID | Description | Location | Asbestos Result <sup>2</sup> | Asbestos Type | ACM Category | Friable Y/N | Quantity |
|---|---|---|---|---|---|---|---|---|
| 2/27/2023 | FAI-120-270223-004, 005, 006 | White Square Vinyl Sheet Flooring | Interior, Kitchen (2 <sup>nd</sup> layer) | None Detected | N/A | N/A | N | 144 sf |

FAI-120-270223-004, 005, 006  
None Detected, White Square  
Vinyl Sheet Flooring

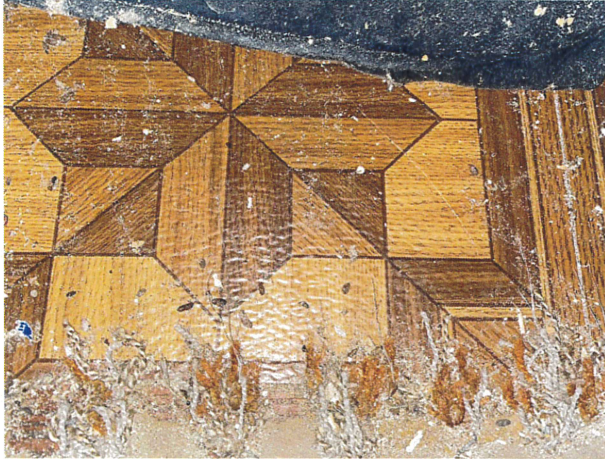
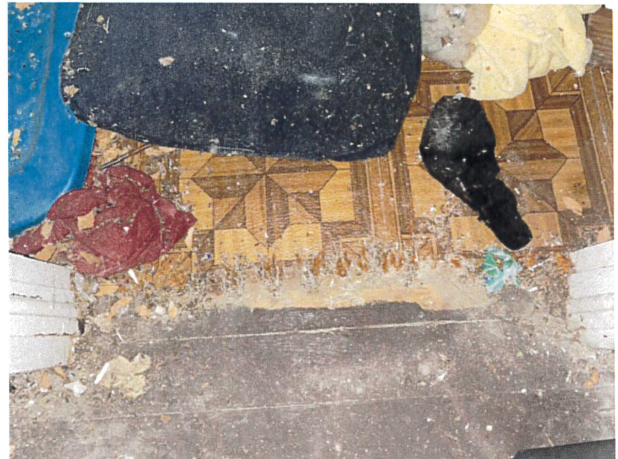
| Sample Date | Sample ID | Description | Location | Asbestos Result <sup>2</sup> | Asbestos Type | ACM Category | Friable Y/N | Quantity |
|---|---|---|---|---|---|---|---|---|
| 2/27/2023 | FAI-120-270223-007, 008, 009 | Wood Pattern Vinyl Sheet Flooring | Interior, Closet | None Detected | N/A | N/A | N | 32 sf |

FAI-120-270223-007, 008, 009  
None Detected, Wood Pattern  
Vinyl Sheet Flooring

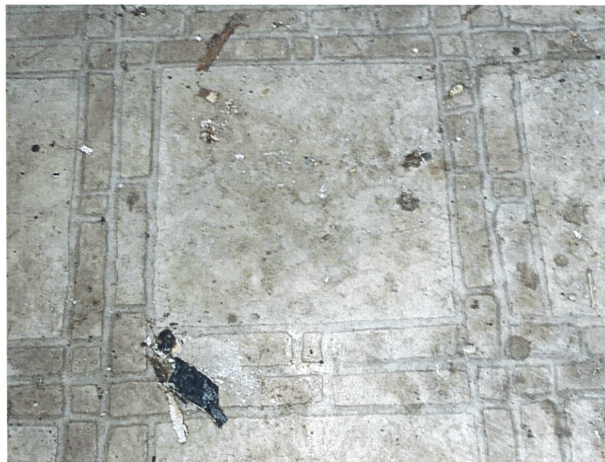
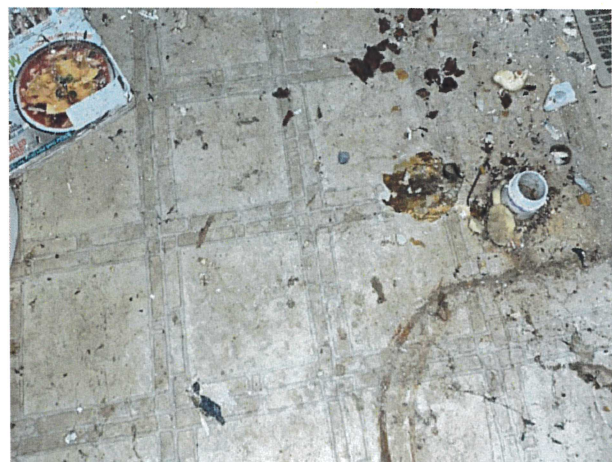
| Sample Date | Sample ID | Description | Location | Asbestos Result <sup>2</sup> | Asbestos Type | ACM Category | Friable Y/N | Quantity |
|---|---|---|---|---|---|---|---|---|
| 2/27/2023 | FAI-120-270223-010, 011, 012 | Cream Square Vinyl Sheet Flooring | Interior, Bathroom | None Detected | N/A | N/A | N | 64 sf |

FAI-120-270223-010, 011, 012  
None Detected, Cream Square  
Vinyl Sheet Flooring

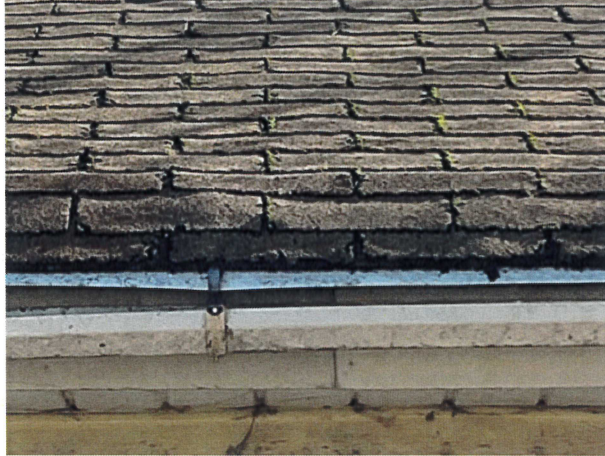
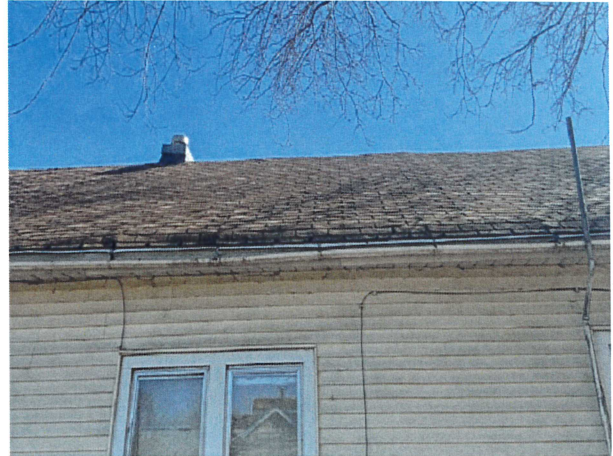
| Sample Date | Sample ID | Description | Location | Asbestos Result <sup>2</sup> | Asbestos Type | ACM Category | Friable Y/N | Quantity |
|---|---|---|---|---|---|---|---|---|
| 2/27/2023 | FAI-120-270223-013, 014, 015, 016, 017 | Brown Shingles | Exterior, Roof | None Detected | N/A | N/A | N | 1,440 sf |

FAI-120-270223-013, 014, 015,  
016, 017 None Detected, Brown  
Shingles

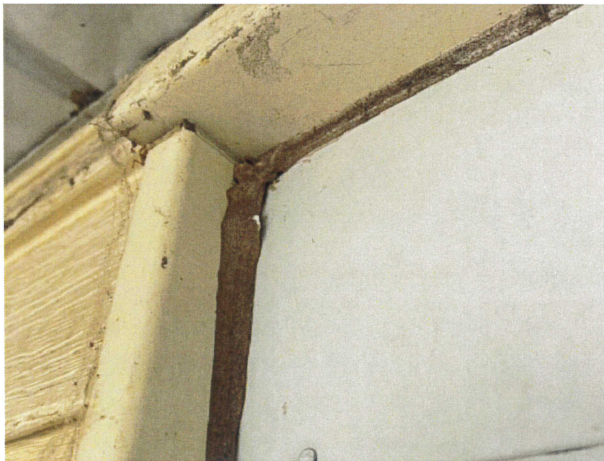
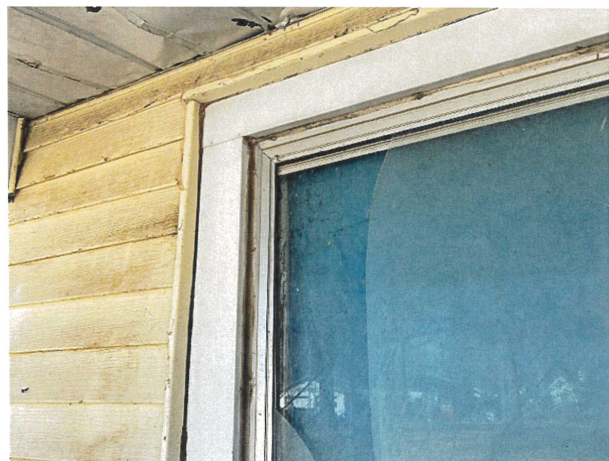
| Sample Date | Sample ID | Description | Location | Asbestos Result <sup>2</sup> | Asbestos Type | ACM Category | Friable Y/N | Quantity |
|---|---|---|---|---|---|---|---|---|
| 2/27/2023 | FAI-120-270223-018, 019, 020 | White Caulk | Exterior, Window & Back Door seams | None Detected | N/A | N/A | N | 5 sf |

FAI-120-270223-018, 019, 020  
None Detected, White Caulk
