RE: Fairbury Asbestos Inspection Report  
Property of Michael Soalfeld  
121 W 3<sup>rd</sup> Street  
Fairbury, NE 68352  
40.134250° N, 97.186489° W

## Building Asbestos Inspection Report

Inspection Date: 2/10/2023

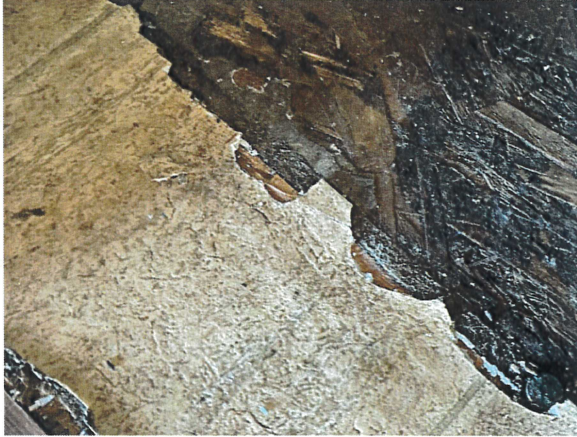
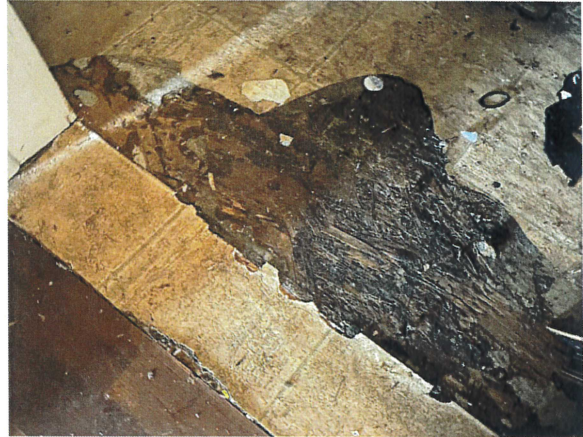
| Sample Date | Sample ID | Description | Location | Asbestos Result <sup>2</sup> | Asbestos Type | ACM Category | Friable Y/N | Quantity |
|---|---|---|---|---|---|---|---|---|
| 2/10/2023 | FAI-210-100223-001, 002, 003 | Tan Vinyl Sheet Flooring | Interior, Bathroom | None Detected | N/A | N/A | N | 64 sf |

FAI-121-100223-001, 002, 003  
None Detected, Tan Vinyl Sheet  
Flooring

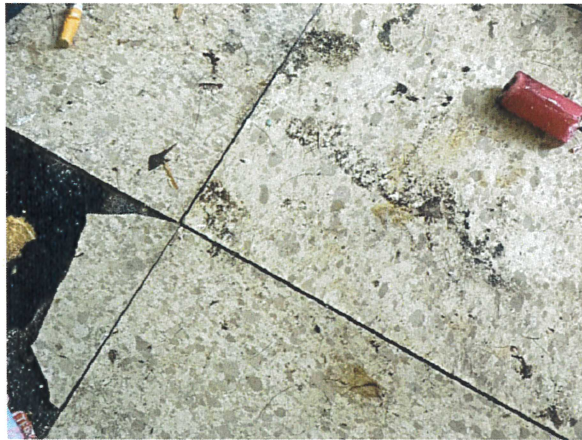
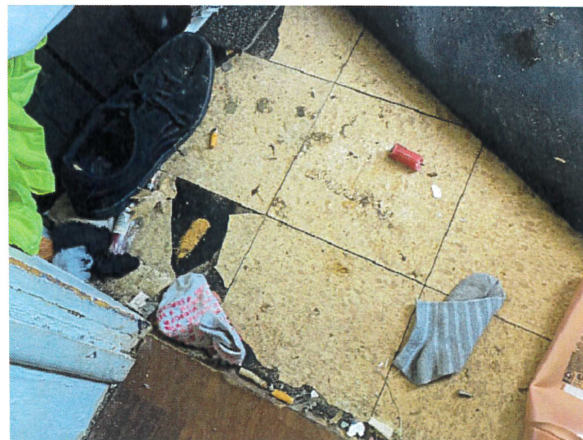
| Sample Date | Sample ID | Description | Location | Asbestos Result <sup>2</sup> | Asbestos Type | ACM Category | Friable Y/N | Quantity |
|---|---|---|---|---|---|---|---|---|
| 2/10/2023 | FAI-210-100223-004, 005, 006 | 9" x 9" Tan Vinyl Floor Tile | Interior, Bed 2 | 3% Detected | Chrysotile | Cat 1 | N | 100 sf |

FAI-121-100223-004, 005, 006 **3%**,  
9" x 9" Tan Vinyl Floor Tile

| Lab Sample Number | Client Sample Number | Layer Type | Lab Gross Description | Asbestos | Other Materials |
|---|---|---|---|---|---|
| 23-02-04753-004A | FAI-210-100223-004 | Tile | Tan Vinyl; Homogeneous | 3% Chrysotile | 97% Non-Fibrous |

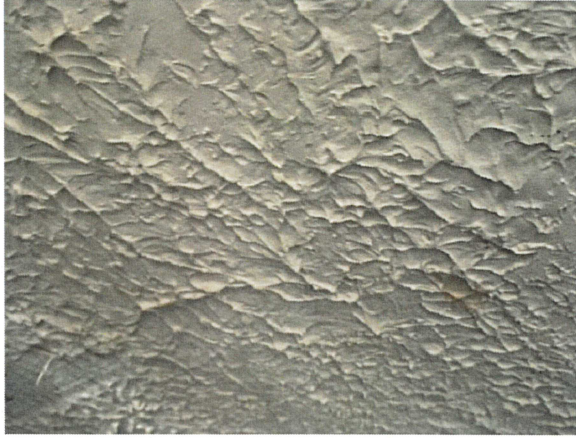
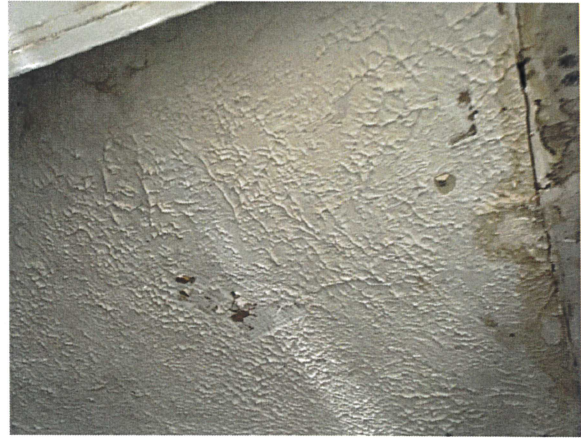
| Sample Date | Sample ID | Description | Location | Asbestos Result <sup>2</sup> | Asbestos Type | ACM Category | Friable Y/N | Quantity |
|---|---|---|---|---|---|---|---|---|
| 2/10/2023 | FAI-210-100223-007, 008, 009 | Ceiling Texture | Interior, Bathroom | None Detected | N/A | N/A | N | 64 sf |

FAI-121-100223-007, 008, 009  
None Detected, Ceiling Texture

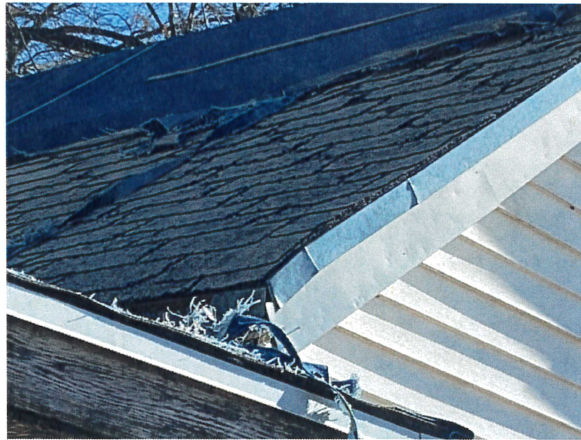
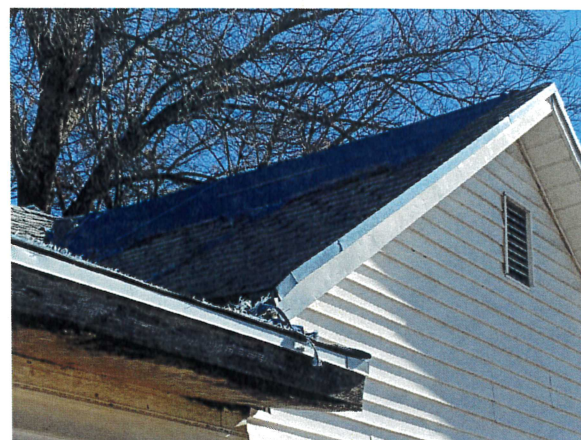
| Sample Date | Sample ID | Description | Location | Asbestos Result <sup>2</sup> | Asbestos Type | ACM Category | Friable Y/N | Quantity |
|---|---|---|---|---|---|---|---|---|
| 2/10/2023 | FAI-210-100223-010, 011, 012, 013, 014 | Gray Shingles | Exterior, Roof | None Detected | N/A | N/A | N | 1,350 sf |

FAI-121-100223-010, 011, 012,  
013, 014 None Detected, Gray  
Shingles

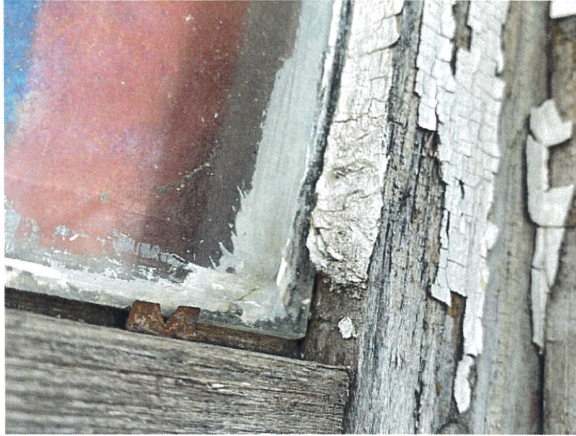
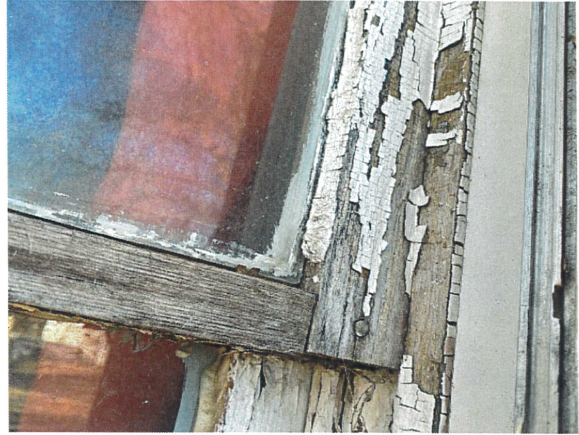
| Sample Date | Sample ID | Description | Location | Asbestos Result <sup>2</sup> | Asbestos Type | ACM Category | Friable Y/N | Quantity |
|---|---|---|---|---|---|---|---|---|
| 2/10/2023 | FAI-210-100223-015, 016, 017 | White Caulk | Exterior, Window seams | <1% | Chrysotile | N/A | N | 6 sf |

FAI-121-100223-015, 016, 017  
<1%, White Caulk

| Lab Sample Number | Client Sample Number | Layer Type | Lab Gross Description | Asbestos | Other Materials |
|---|---|---|---|---|---|
| 23-02-04753-016C | FAI-210-100223-016 | Caulk III | Tan Brittle; White Paint-Like; Inhomogeneous | Trace <1% Chrysotile | 100% Non-Fibrous |
