RE: Fairbury Asbestos Inspection Report  
Property of David & Megan Tracy  
204 W 3<sup>rd</sup> Street  
Fairbury, NE 68352  
40.133883° N, 97.187575° W

## Building Asbestos Inspection Report

Inspection Date: 2/10/2023

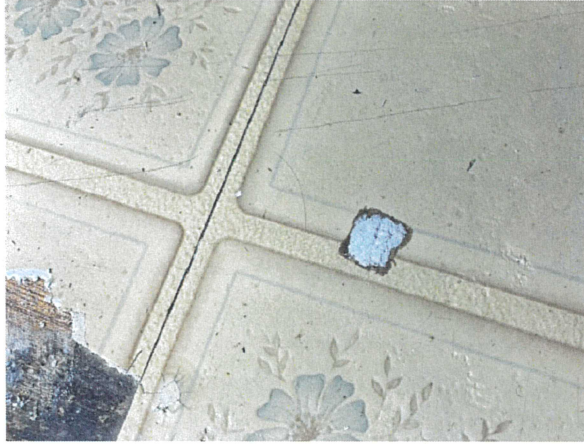
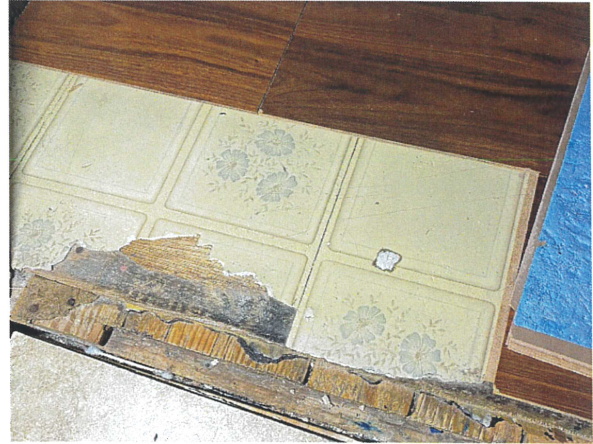
| Sample Date | Sample ID | Description | Location | Asbestos Result <sup>2</sup> | Asbestos Type | ACM Category | Friable Y/N | Quantity |
|---|---|---|---|---|---|---|---|---|
| 2/10/2023 | FAI-204-100223-001, 002, 003 | Cream Vinyl Sheet Flooring | Interior, Dining Room & Kitchen (2 <sup>nd</sup> layer from top) | None | N/A | N/A | N | 465 sf |

FAI-204-100223-001, 002, 003  
None Detected, Cream Vinyl Sheet  
Flooring

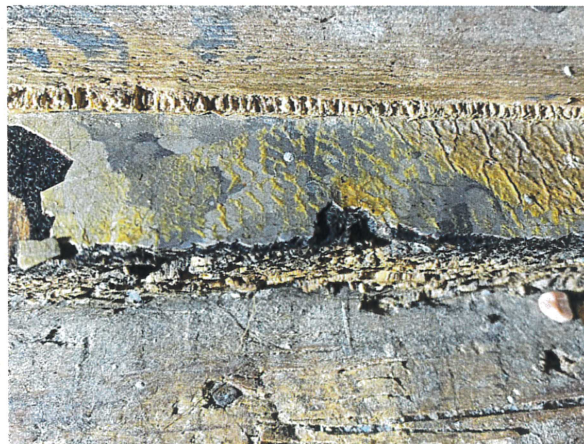
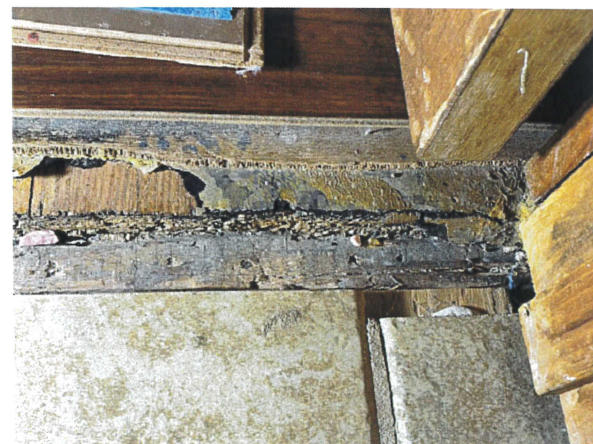
| Sample Date | Sample ID | Description | Location | Asbestos Result <sup>2</sup> | Asbestos Type | ACM Category | Friable Y/N | Quantity |
|---|---|---|---|---|---|---|---|---|
| 2/10/2023 | FAI-204-100223-004, 005, 006 | Gray Vinyl Sheet Flooring | Interior, Dining Room & Kitchen (4 <sup>th</sup> layer from top) | None | N/A | N/A | N | 465 sf |

FAI-204-100223-004, 005, 006  
None Detected, Gray Vinyl Sheet  
Flooring

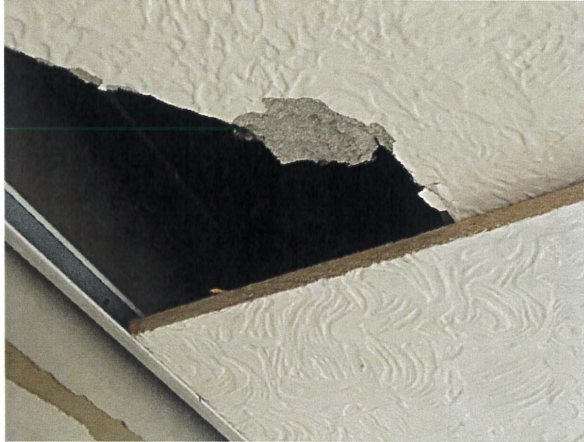
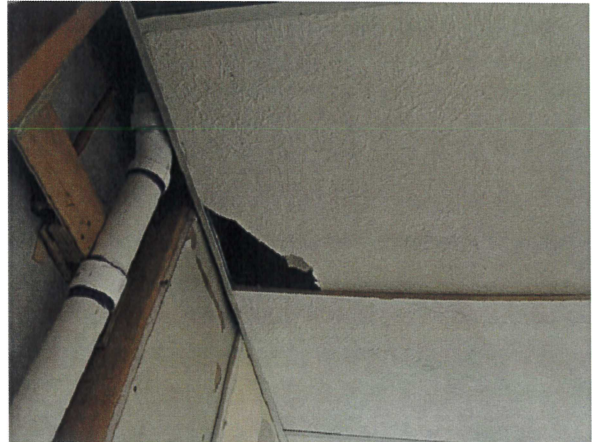
| Sample Date | Sample ID | Description | Location | Asbestos Result <sup>2</sup> | Asbestos Type | ACM Category | Friable Y/N | Quantity |
|---|---|---|---|---|---|---|---|---|
| 2/10/2023 | FAI-204-100223-007, 008, 009 | White Ceiling Tile | Interior, Hallway, Bed 1, & Bed 3 ceilings | None | N/A | N/A | N | 563 sf |

FAI-204-100223-007, 008, 009  
None Detected, White Ceiling Tile

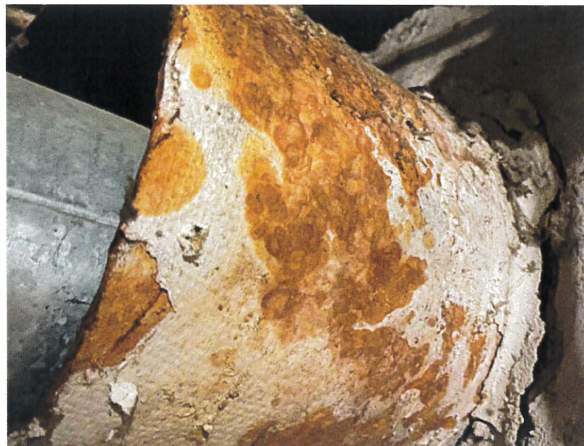
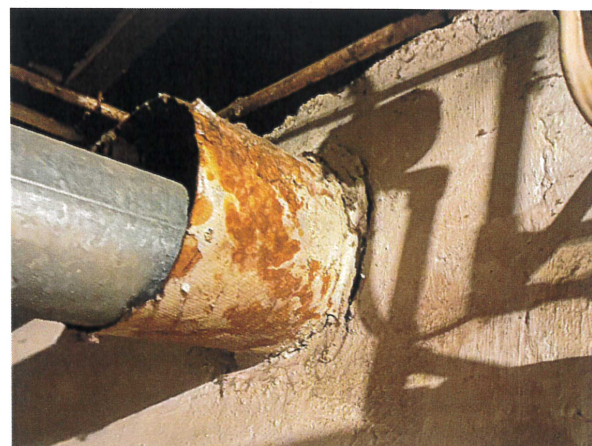
| Sample Date | Sample ID | Description | Location | Asbestos Result <sup>2</sup> | Asbestos Type | ACM Category | Friable Y/N | Quantity |
|---|---|---|---|---|---|---|---|---|
| 2/10/2023 | FAI-204-100223-010, 011, 012 | White Pipe Insulation | Interior, Basement: pipe in NE wall | 60% | Chrysotile | RACM | N | 5 sf |

FAI-204-100223-010, 011, 012  
60%, White Pipe Insulation

| Lab Sample Number | Client Sample Number | Layer Type | Lab Gross Description | Asbestos | Other Materials |
|---|---|---|---|---|---|
| 23-02-04754-010 | FAI-204-100223-010 | | Off-White Fibrous; Homogeneous | 60% Chrysotile | 35% Cellulose<br>5% Non-Fibrous |

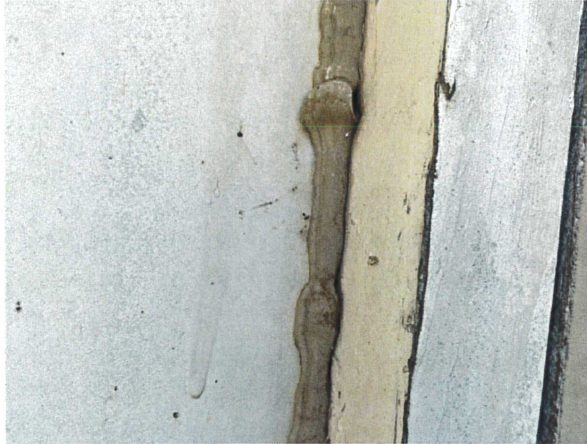
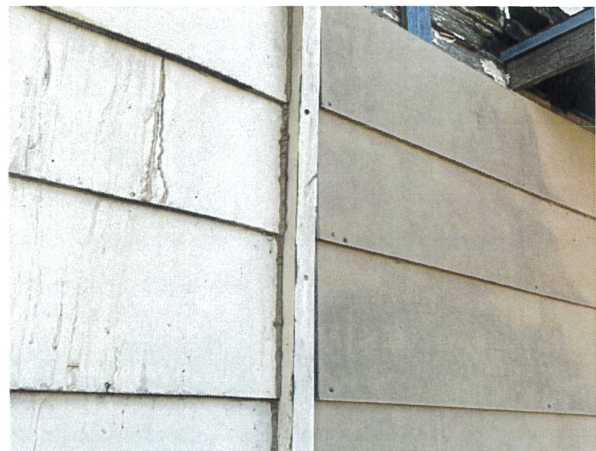
| Sample Date | Sample ID | Description | Location | Asbestos Result <sup>2</sup> | Asbestos Type | ACM Category | Friable Y/N | Quantity |
|---|---|---|---|---|---|---|---|---|
| 2/10/2023 | FAI-204-100223-013, 014, 015 | White Caulk | Exterior, Door, Window, & Siding seams | None | N/A | N/A | N | 12 sf |

FAI-204-100223-013, 014, 015  
None Detected, White Caulk

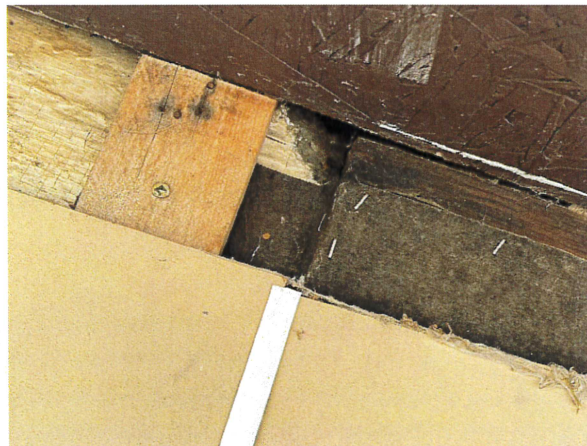
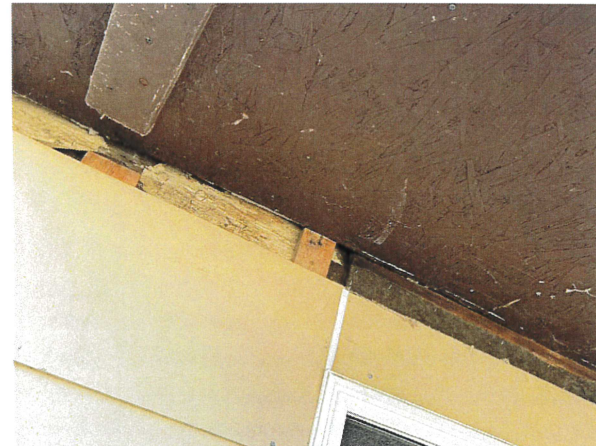
| Sample Date | Sample ID | Description | Location | Asbestos Result <sup>2</sup> | Asbestos Type | ACM Category | Friable Y/N | Quantity |
|---|---|---|---|---|---|---|---|---|
| 2/10/2023 | FAI-204-100223-016, 017, 018, 019, 020 | Black Felt Paper | Exterior, Walls behind siding | None | N/A | N/A | N | 2,047 sf |

FAI-204-100223-016, 017, 018,  
019, 020 None Detected, Black  
Felt Paper
