RE: Fairbury Asbestos Inspection Report  
Property of Teresa Smith  
306 W 3<sup>rd</sup> Street  
Fairbury, NE 68352  
40.133856° N, 97.188881° W

## Building Asbestos Inspection Report

Inspection Date: 2/09/2023

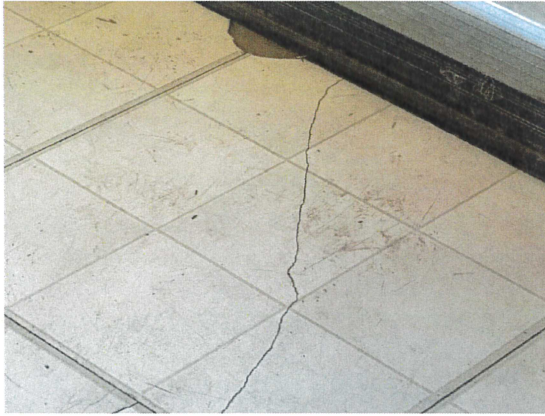
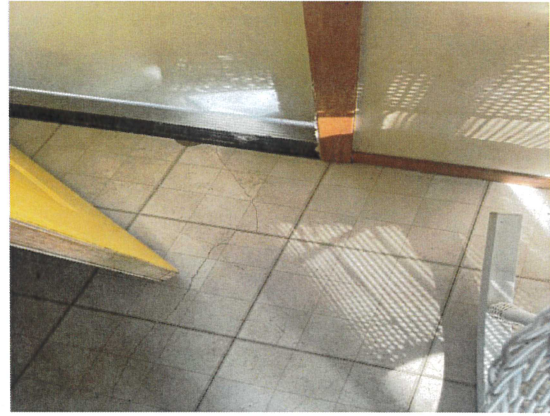
| Sample Date | Sample ID | Description | Location | Asbestos Result <sup>2</sup> | Asbestos Type | ACM Category | Friable Y/N | Quantity |
|---|---|---|---|---|---|---|---|---|
| 2/09/2023 | FAI-306-090223-001, 002, 003 | 12" x 12" White Vinyl Floor Tile | Interior, Mud room | None Detected | N/A | N/A | N | 121 sf |

FAI-306-090223-001, 002, 003  
None Detected, 12" x 12" White  
Vinyl Floor Tile

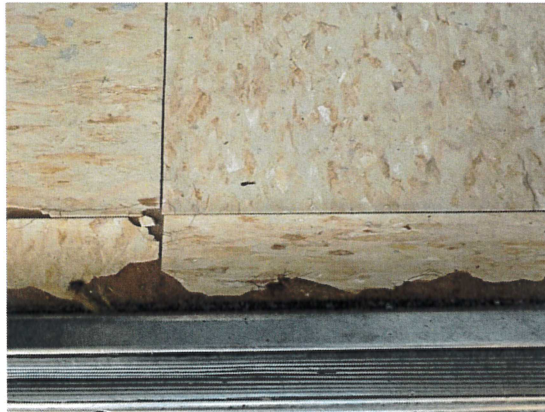
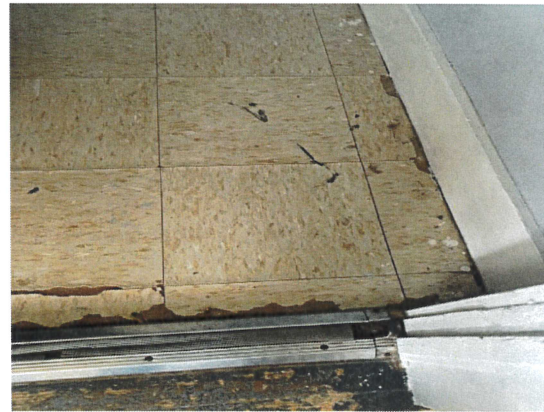
| Sample Date | Sample ID | Description | Location | Asbestos Result <sup>2</sup> | Asbestos Type | ACM Category | Friable Y/N | Quantity |
|---|---|---|---|---|---|---|---|---|
| 2/09/2023 | FAI-306-090223-004, 005, 006 | 12" x 12" Tan Vinyl Floor Tile | Interior, Living room | <span style="color: red;">2%</span> | Chrysotile | Cat 1 | N | 144 sf |

FAI-306-090223-004, 005, 006 2%,  
12" x 12" Tan Vinyl Floor Tile

| Lab Sample Number | Client Sample Number | Layer Type | Lab Gross Description | Asbestos | Other Materials |
|---|---|---|---|---|---|
| 23-02-04529-004A | FAI-306-090223-004 | Tile | Beige Vinyl-Like; Homogenous | 2% Chrysotile | 98% Non-Fibrous |

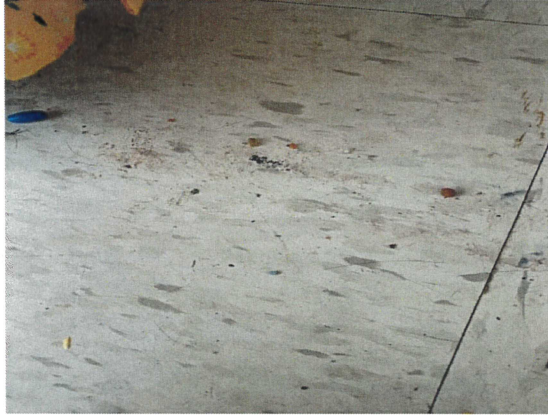
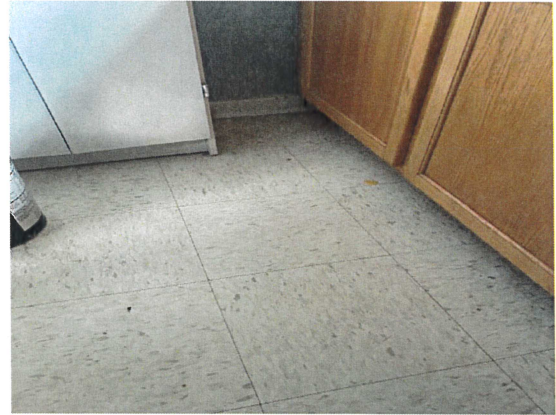
| Sample Date | Sample ID | Description | Location | Asbestos Result <sup>2</sup> | Asbestos Type | ACM Category | Friable Y/N | Quantity |
|---|---|---|---|---|---|---|---|---|
| 2/09/2023 | FAI-306-090223-007, 008, 009 | 12" x 12" White Vinyl Floor Tile | Interior, Kitchen | None Detected | N/A | N/A | N | 180 sf |

FAI-306-090223-007, 008, 009  
None Detected, 12" x 12" White  
Vinyl Floor Tile

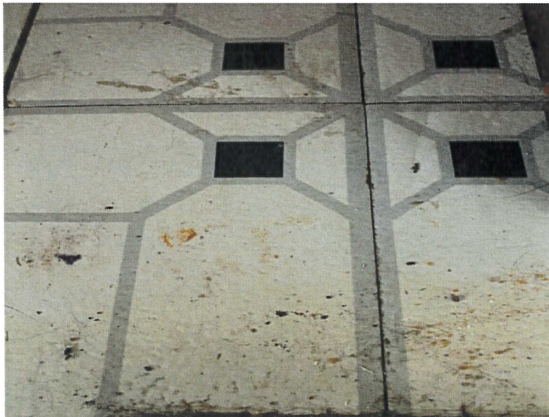
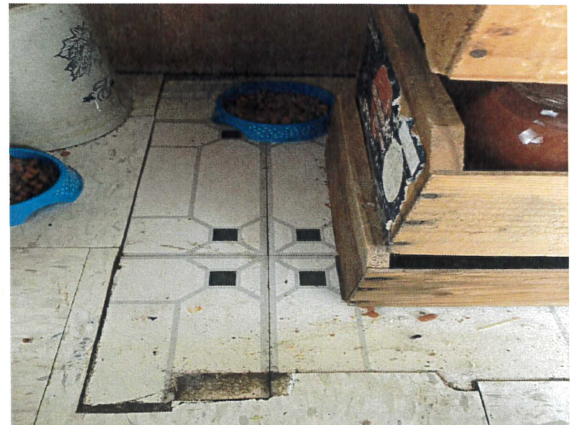
| Sample Date | Sample ID | Description | Location | Asbestos Result <sup>2</sup> | Asbestos Type | ACM Category | Friable Y/N | Quantity |
|---|---|---|---|---|---|---|---|---|
| 2/09/2023 | FAI-306-090223-010, 011, 012 | 12" x 12" White & Green Vinyl Floor Tile | Interior, Kitchen: under counter | None Detected | N/A | N/A | N | 6 sf |

FAI-306-090223-010, 011, 012  
None Detected, 12" x 12" White &  
Green Vinyl Floor Tile

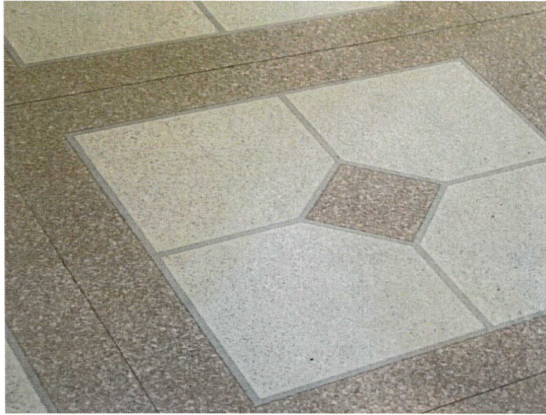
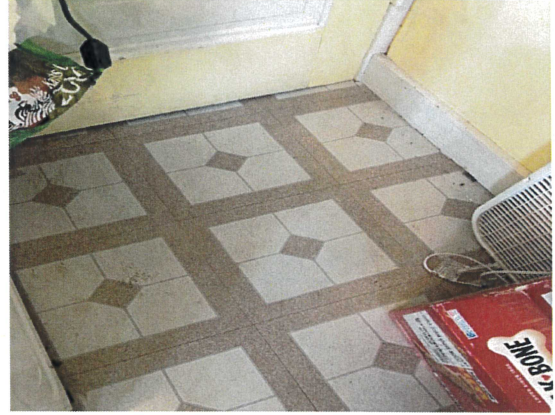
| Sample Date | Sample ID | Description | Location | Asbestos Result <sup>2</sup> | Asbestos Type | ACM Category | Friable Y/N | Quantity |
|---|---|---|---|---|---|---|---|---|
| 2/09/2023 | FAI-306-090223-013, 014, 015 | 12" x 12" Tan Vinyl Floor Tile | Interior, Laundry room | None Detected | N/A | N/A | N | 78 sf |

FAI-306-090223-013, 014, 015  
None Detected, 12" x 12" Tan  
Vinyl Floor Tile

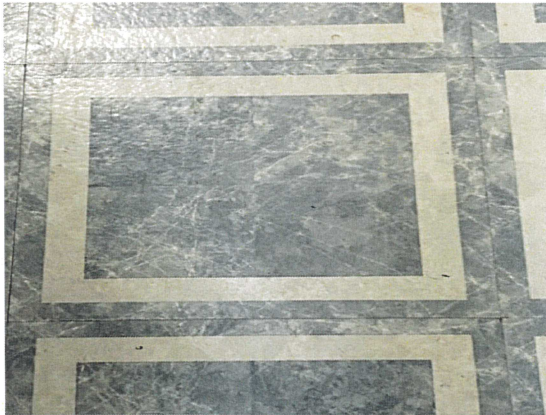
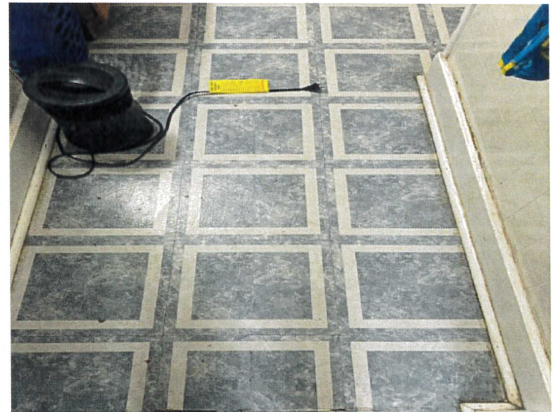
| Sample Date | Sample ID | Description | Location | Asbestos Result <sup>2</sup> | Asbestos Type | ACM Category | Friable Y/N | Quantity |
|---|---|---|---|---|---|---|---|---|
| 2/09/2023 | FAI-306-090223-016, 017, 018 | 12" x 12" Blue Vinyl Floor Tile | Interior, Bathroom | None Detected | N/A | N/A | N | 45 sf |

FAI-306-090223-016, 017, 018  
None Detected, 12" x 12" Blue  
Vinyl Floor Tile

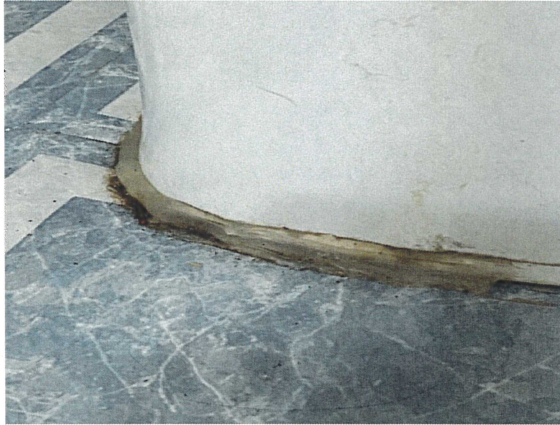
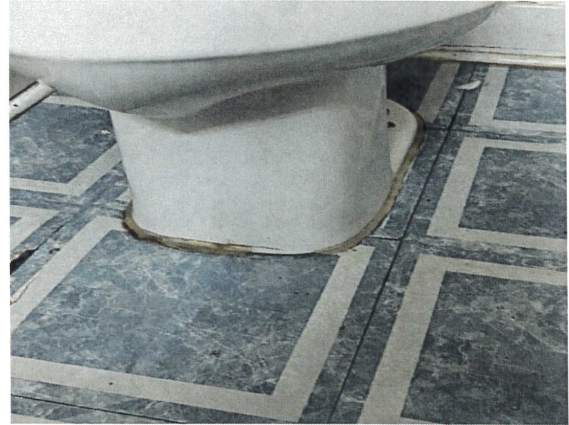
| Sample Date | Sample ID | Description | Location | Asbestos Result <sup>2</sup> | Asbestos Type | ACM Category | Friable Y/N | Quantity |
|---|---|---|---|---|---|---|---|---|
| 2/09/2023 | FAI-306-090223-019, 020, 021 | Clear Caulk | Interior, Bathroom: base of toilet | None Detected | N/A | N/A | N | 2 sf |

FAI-306-090223-019, 020, 021  
None Detected, Clear Caulk

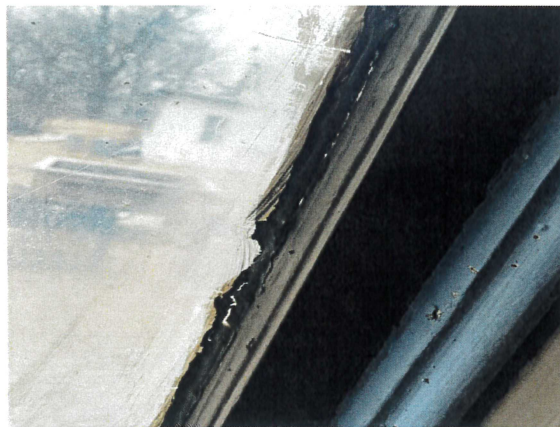
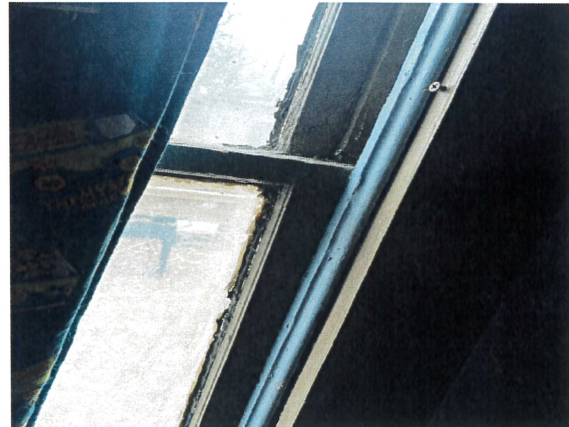
| Sample Date | Sample ID | Description | Location | Asbestos Result <sup>2</sup> | Asbestos Type | ACM Category | Friable Y/N | Quantity |
|---|---|---|---|---|---|---|---|---|
| 2/09/2023 | FAI-306-090223-022, 023, 024 | White Caulk | Interior, Window seams | None Detected | N/A | N/A | N | 12 sf |

FAI-306-090223-022, 023, 024  
None Detected, White Caulk

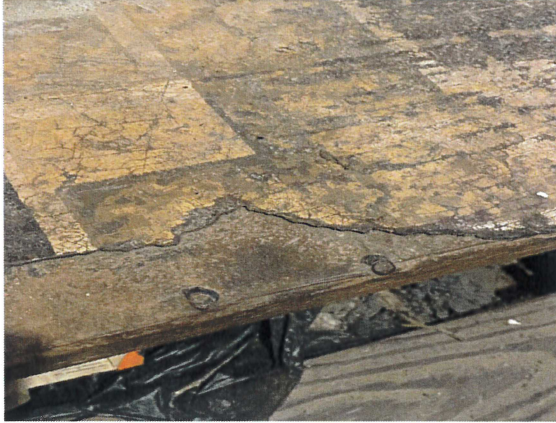
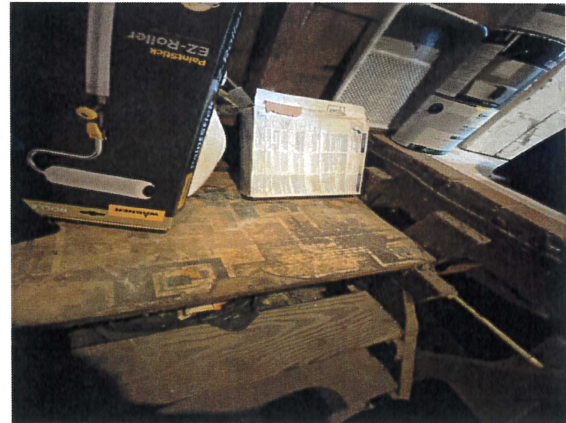
| Sample Date | Sample ID | Description | Location | Asbestos Result <sup>2</sup> | Asbestos Type | ACM Category | Friable Y/N | Quantity |
|---|---|---|---|---|---|---|---|---|
| 2/09/2023 | FAI-306-090223-025, 026, 027 | Muti-colored Vinyl Sheet Flooring | Interior, Laundry room & steps to basement under wood layer | None Detected | N/A | N/A | N | 100 sf |

FAI-306-090223-025, 026, 027  
None Detected, Multi-colored  
Vinyl Sheet Flooring

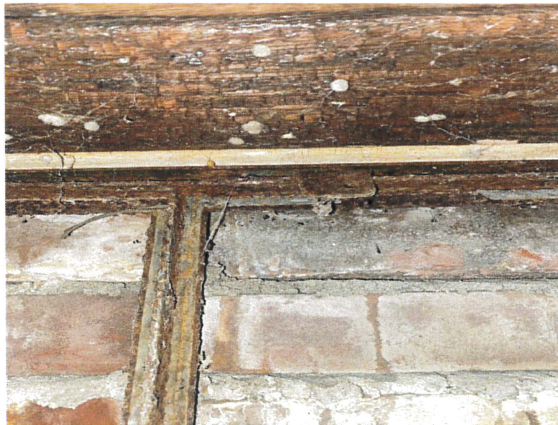
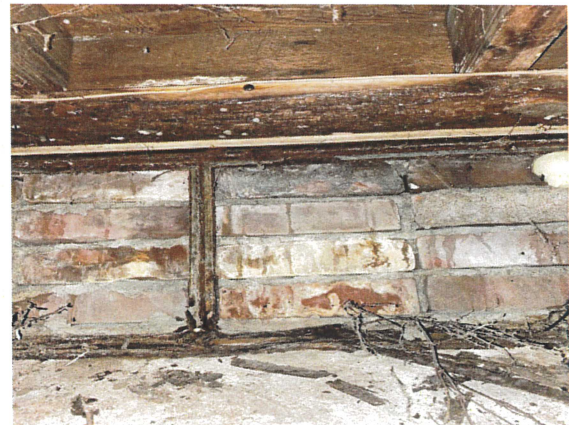
| Sample Date | Sample ID | Description | Location | Asbestos Result <sup>3</sup> | Asbestos Type | ACM Category | Friable Y/N | Quantity |
|---|---|---|---|---|---|---|---|---|
| 2/09/2023 | FAI-306-090223-028, 029, 030 | Gray Window Glazing | Interior, Basement, foundation window seams | None Detected | N/A | N/A | N | 6 sf |

FAI-306-090223-028, 029, 030  
None Detected, Gray Window  
Glazing
