RE: Fairbury Asbestos Inspection Report

Property of Randy Griffin

321 W 3<sup>rd</sup> Street

## Building Asbestos Inspection Report

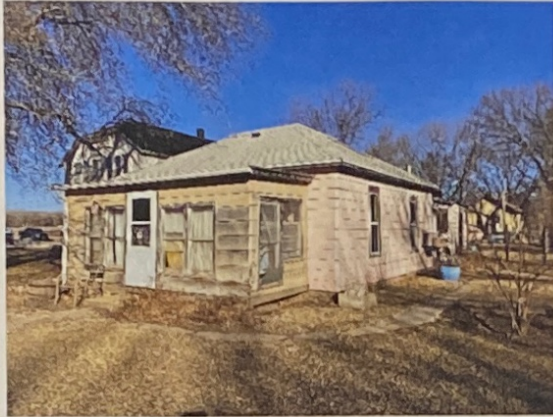
Southeast exterior elevation  
viewing northwest

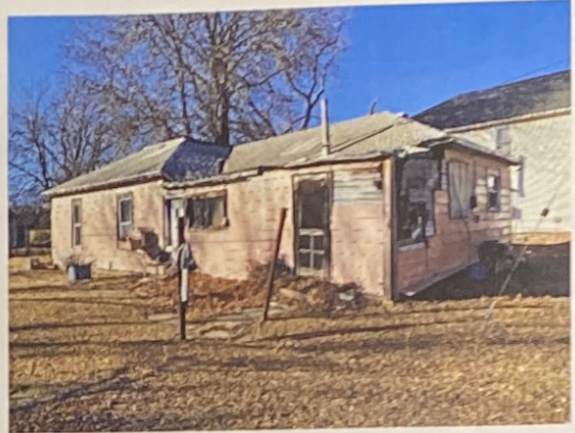
Northeast exterior elevation  
viewing southwest

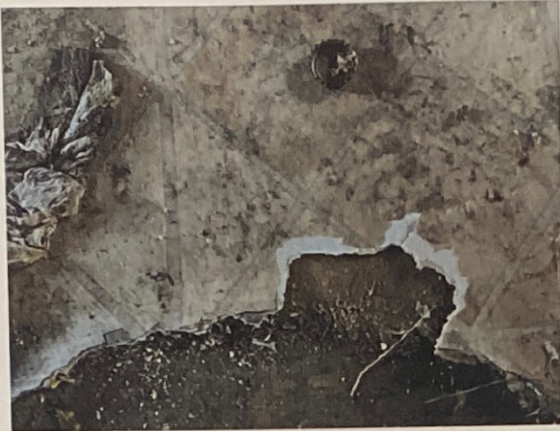
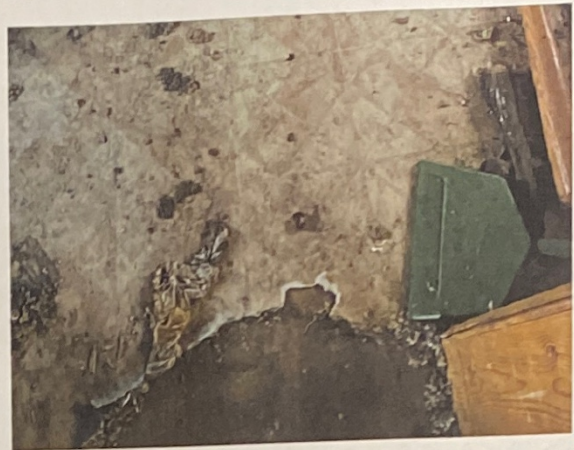
| Sample Date | Sample ID | Description | Location | Asbestos Result <sup>2</sup> | Asbestos Type | ACM Category | Friable Y/N | Quantity |
|---|---|---|---|---|---|---|---|---|
| 2/13/2023 | FAI-321-130223-001, 002, 003 | Tan Vinyl Sheet Flooring | Interior, Dining Room, Kitchen, & Bathroom | None Detected | N/A | N/A | N | 384 sf |

FAI-321-130223-001, 002, 003  
None Detected, Tan Vinyl Sheet  
Flooring

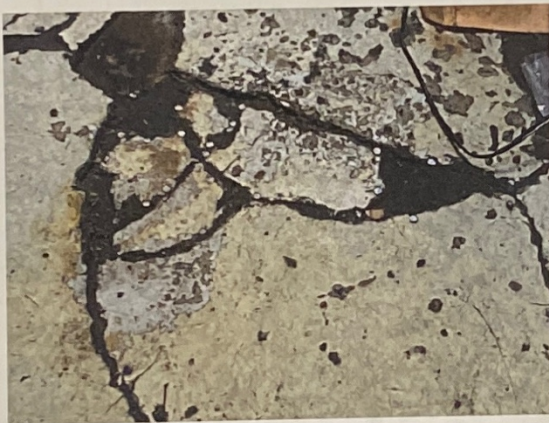
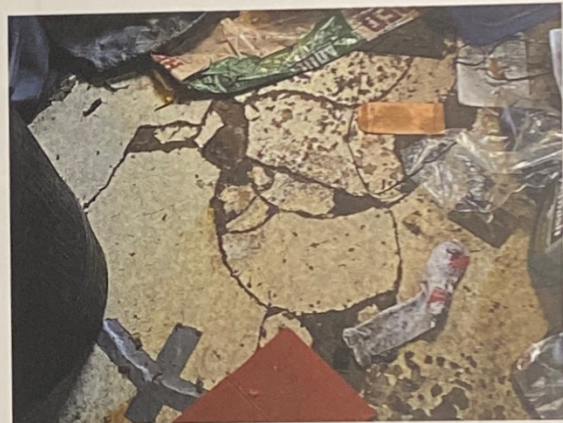
| Sample Date | Sample ID | Description | Location | Asbestos Result <sup>2</sup> | Asbestos Type | ACM Category | Friable Y/N | Quantity |
|---|---|---|---|---|---|---|---|---|
| 2/13/2023 | FAI-321-130223-004, 005, 006 | Cream Vinyl Sheet Flooring | Interior, Mud Room | None Detected | N/A | N/A | N | 49 sf |

FAI-321-130223-004, 005, 006  
None Detected, Cream Vinyl Sheet  
Flooring

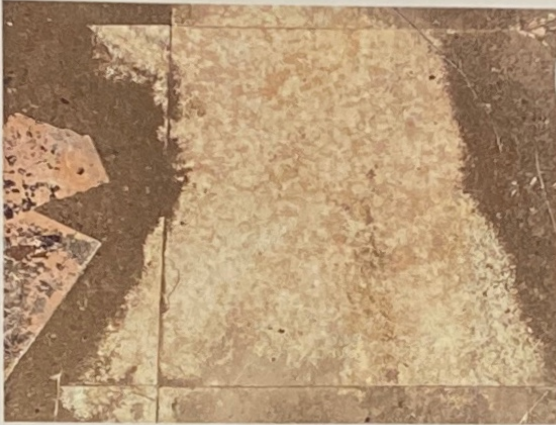
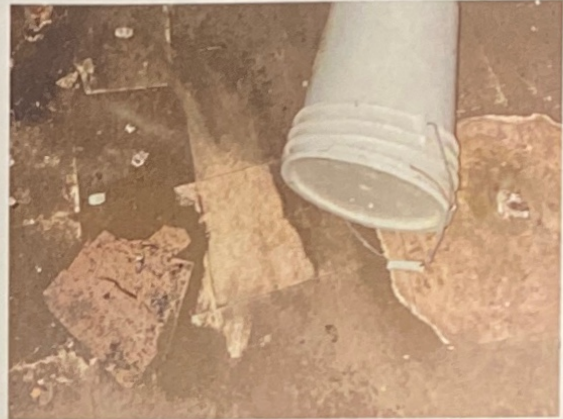
| Sample Date | Sample ID | Description | Location | Asbestos Result <sup>2</sup> | Asbestos Type | ACM Category | Friable Y/N | Quantity |
|---|---|---|---|---|---|---|---|---|
| 2/13/2023 | FAI-321-130223-007, 008, 009 | 9" x 9" Tan Vinyl Floor Tile / Black Mastic | Interior, Basement: office | 3% / 2% | Chrysotile / Chrysotile | Cat 1 / Cat 2 | N | 384 sf |

FAI-321-130223-007, 008, 009 3%  
/ 2%, 9" x 9" Tan Vinyl Floor Tile /  
Black Mastic

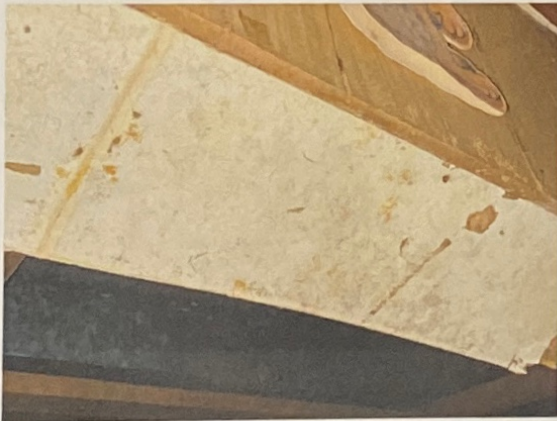
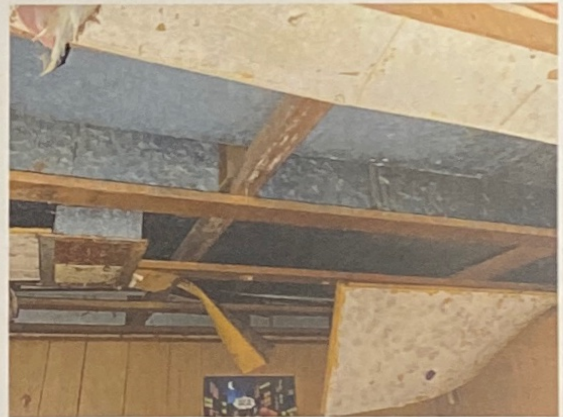
| Sample Date | Sample ID | Description | Location | Asbestos Result <sup>2</sup> | Asbestos Type | ACM Category | Friable Y/N | Quantity |
|---|---|---|---|---|---|---|---|---|
| 2/13/2023 | FAI-321-130223-010, 011, 012 | White Ceiling Tile | Interior, Basement: office (ceiling & debris) | None Detected | N/A | N/A | N | 50 sf |

FAI-321-130223-010, 011, 012  
None Detected, White Ceiling Tile

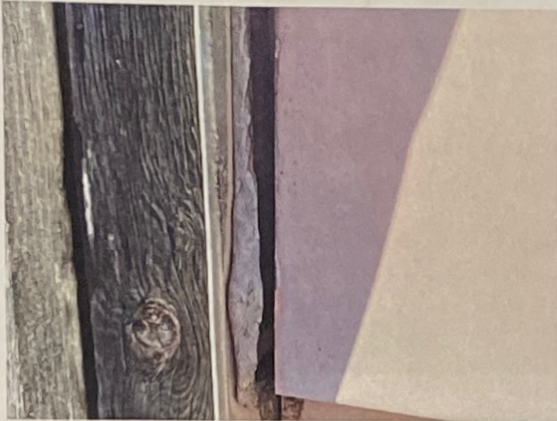
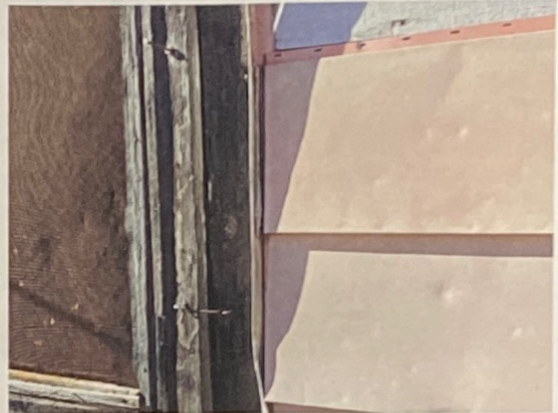
| Sample Date | Sample ID | Description | Location | Asbestos Result <sup>2</sup> | Asbestos Type | ACM Category | Friable Y/N | Quantity |
|---|---|---|---|---|---|---|---|---|
| 2/13/2023 | FAI-321-130223-013, 014, 015 | White Caulk | Exterior, Front Porch Door and Corner seams | 5% | Chrysotile | Cat 2 | N | 6 sf |

FAI-321-130223-013, 014, 015 5%,  
White Caulk

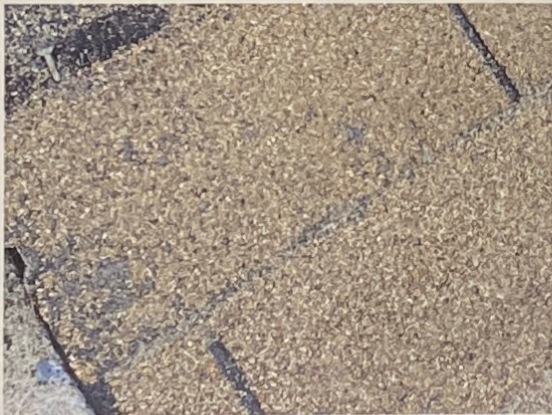
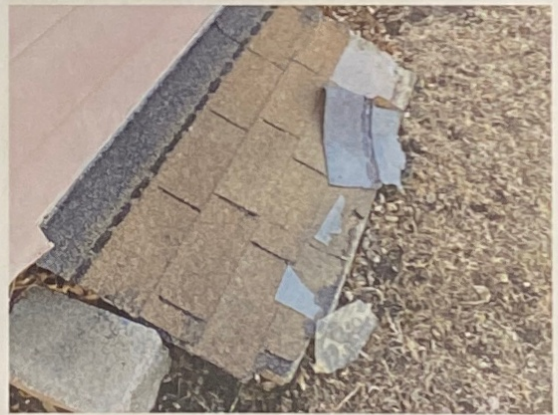
| Sample Date | Sample ID | Description | Location | Asbestos Result <sup>2</sup> | Asbestos Type | ACM Category | Friable Y/N | Quantity |
|---|---|---|---|---|---|---|---|---|
| 2/13/2023 | FAI-321-130223-016, 017, 018 | Brown Shingles | Exterior, Covering Foundation Windows | None Detected | N/A | N/A | N | 10 sf |

FAI-321-130223-016, 017, 018  
None Detected, Brown Shingles

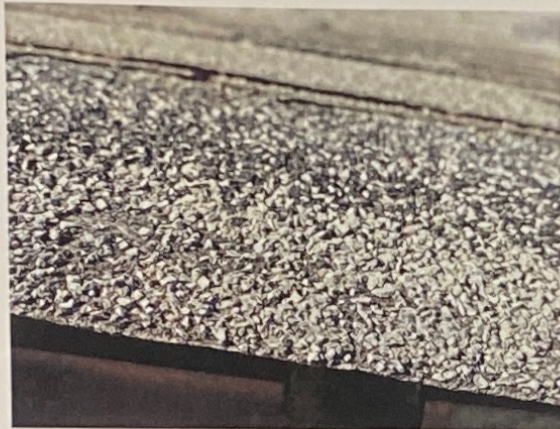
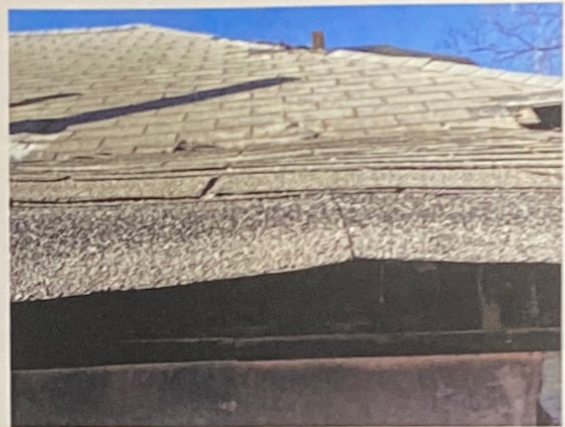
| Sample Date | Sample ID | Description | Location | Asbestos Result <sup>2</sup> | Asbestos Type | ACM Category | Friable Y/N | Quantity |
|---|---|---|---|---|---|---|---|---|
| 2/13/2023 | FAI-321-130223-019, 020, 021, 022, 023 | Gray Shingles | Exterior, Roof | None Detected | N/A | N/A | N | 1,130 sf |

FAI-321-130223-019, 020, 021,  
022, 023 None Detected, Gray  
Shingles

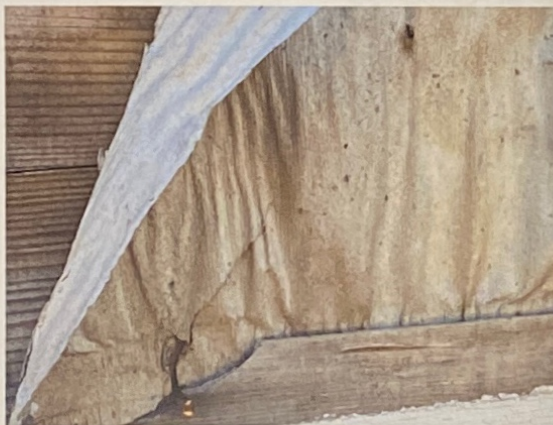
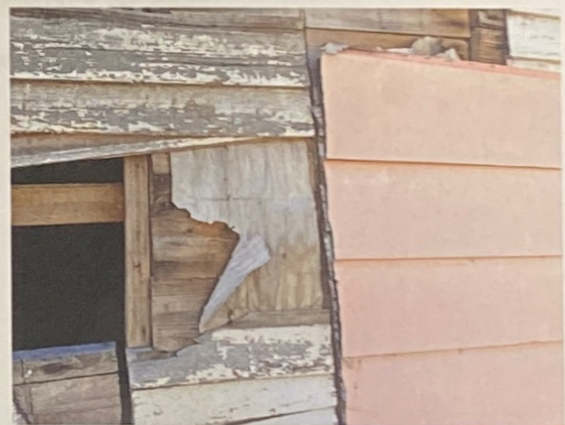
The inspector inadvertently listed sample numbers "FAI-321-130223-024" and "FAI-321-130223-025" as "Gray Felt Paper" on the Chain of Custody. These numbers should be listed as "Gray Shingles, and should be interpreted as such for the Lab Reports and Chain of Custody Receipts section.

| Sample Date | Sample ID | Description | Location | Asbestos Result <sup>2</sup> | Asbestos Type | ACM Category | Friable Y/N | Quantity |
|---|---|---|---|---|---|---|---|---|
| 2/13/2023 | FAI-321-130223-024, 025, 026, 027, 028 | Gray Felt Paper | Exterior, Walls under wood siding | None Detected | N/A | N/A | N | 1,480 sf |

FAI-321-130223-024, 025, 026,  
027, 028 None Detected, Gray Felt  
Paper

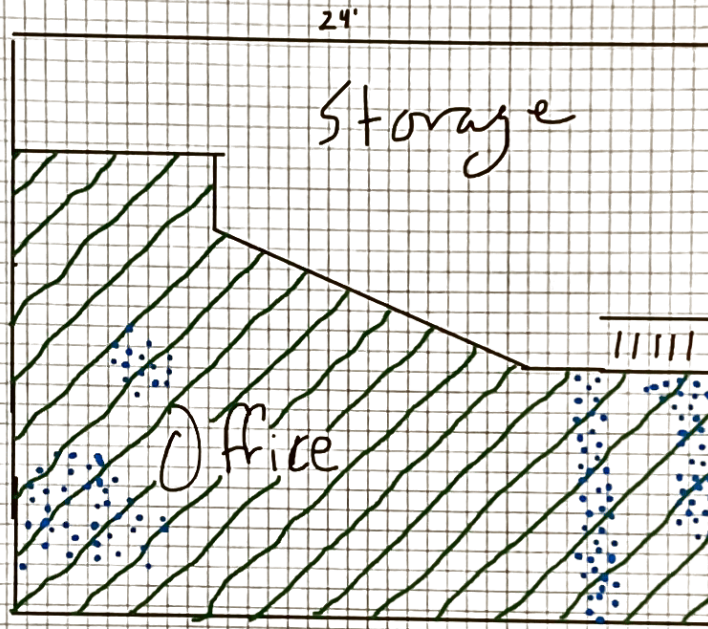
### Hatchings (Basement)

// 9" x 9" Tan VFT  
 ■ White Ceiling Tile
