RE: Fairbury Asbestos Inspection Report

Property of Tammy Reynolds
408 A Street
Fairbury, NE 68352
40.135475° N, 97.185091° W

Building Asbestos Inspection Report

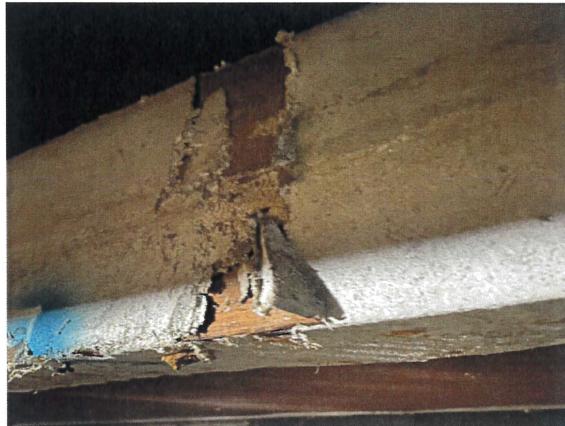
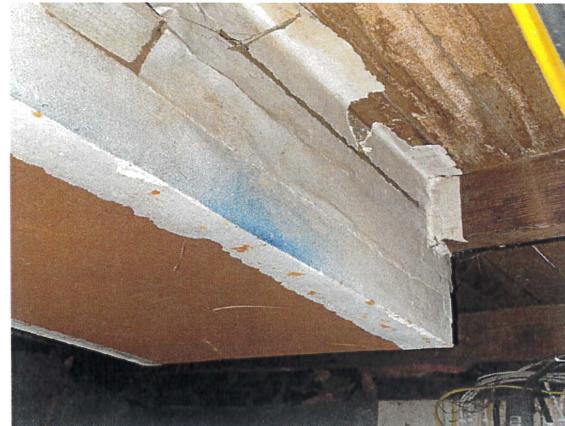
Sample Date	Sample ID	Description	Location	Asbestos Result ²	Asbestos Type	ACM Category	Friable Y/N	Quantity
2/09/2023	FAI-408-090223-001, 002, 003	White Duct Insulation	Interior, Ducts in basement	75%	Chrysotile	RACM	N	30 sf

FAI-408-090223-001, 002, 003
75%, White Duct Insulation

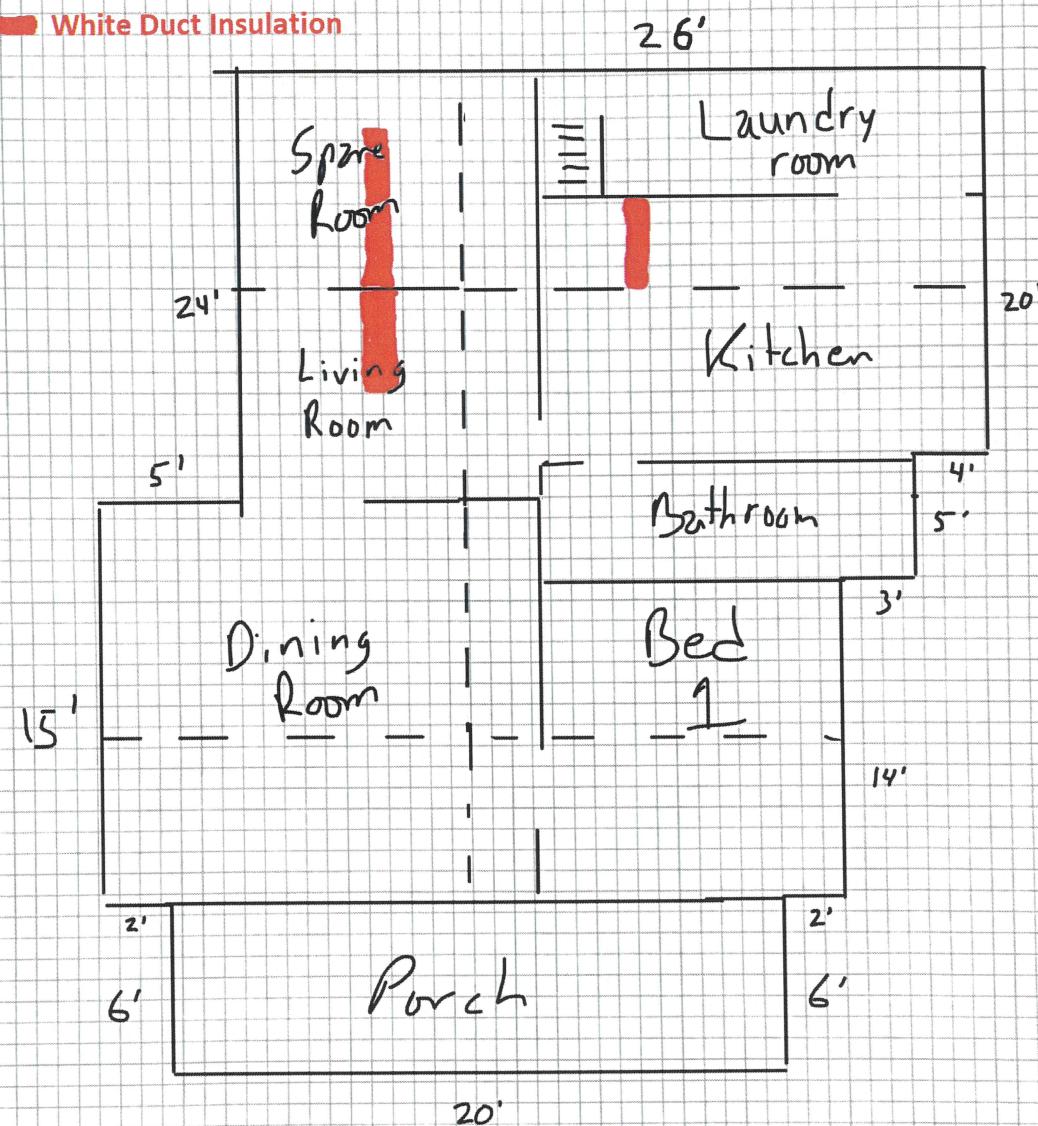
Hatchings

White Duct Insulation
