# PARK & POOL STUDY

PREPARED FOR  
**CITY OF FAIRBURY**  
—  
**FAIRBURY, NEBRASKA**

**MAY 5<sup>TH</sup> 2016**

**OA PROJECT No. 015-2112**

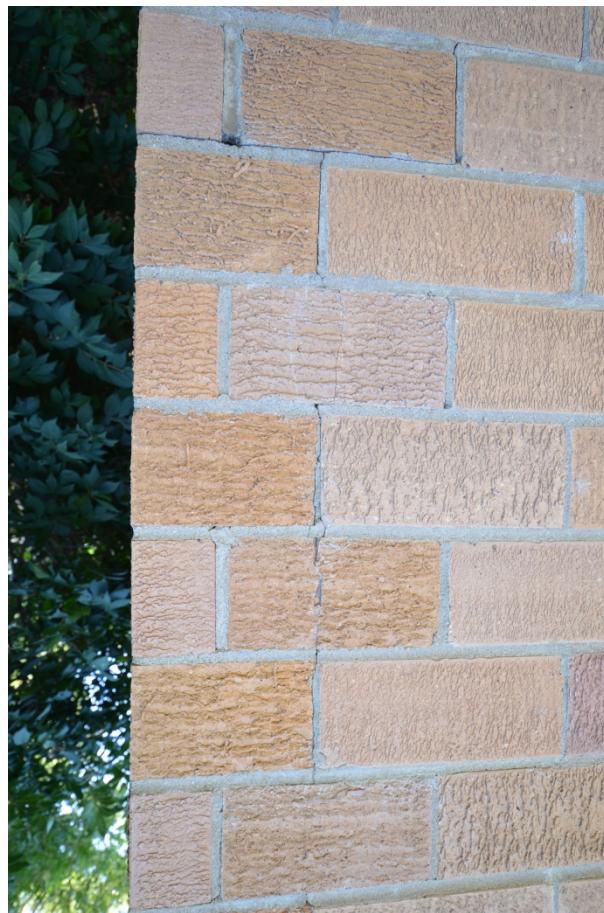
Slight foundation settlement has occurred at the southwest corner as indicated by the stepped diagonal crack in the masonry mortar joints.

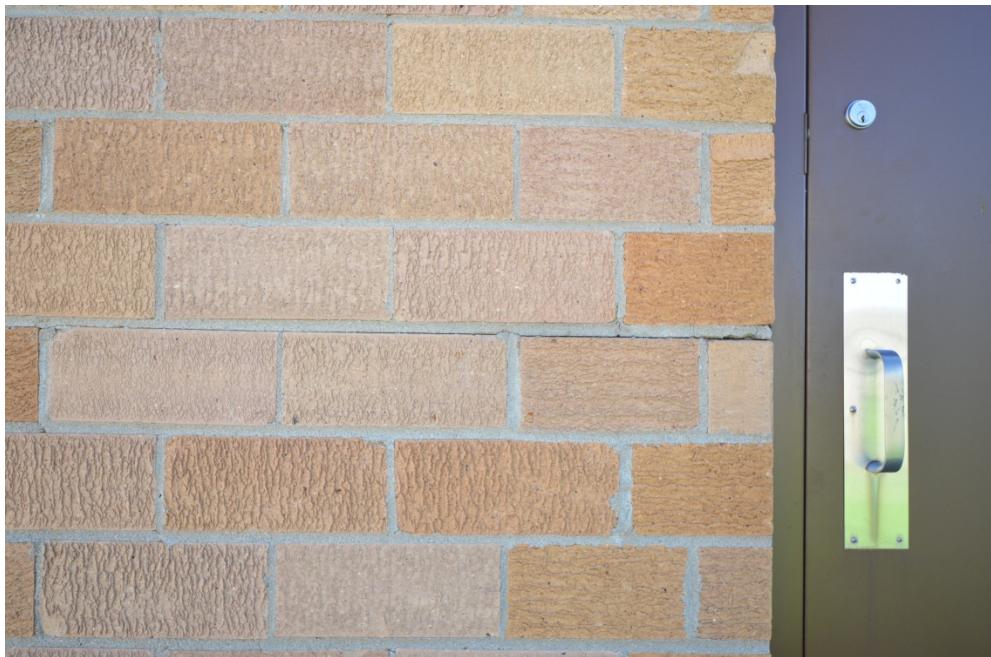
Slight foundation settlement has also occurred at the west door to the public restroom. All other areas of the bathhouse appear to be structurally stable.

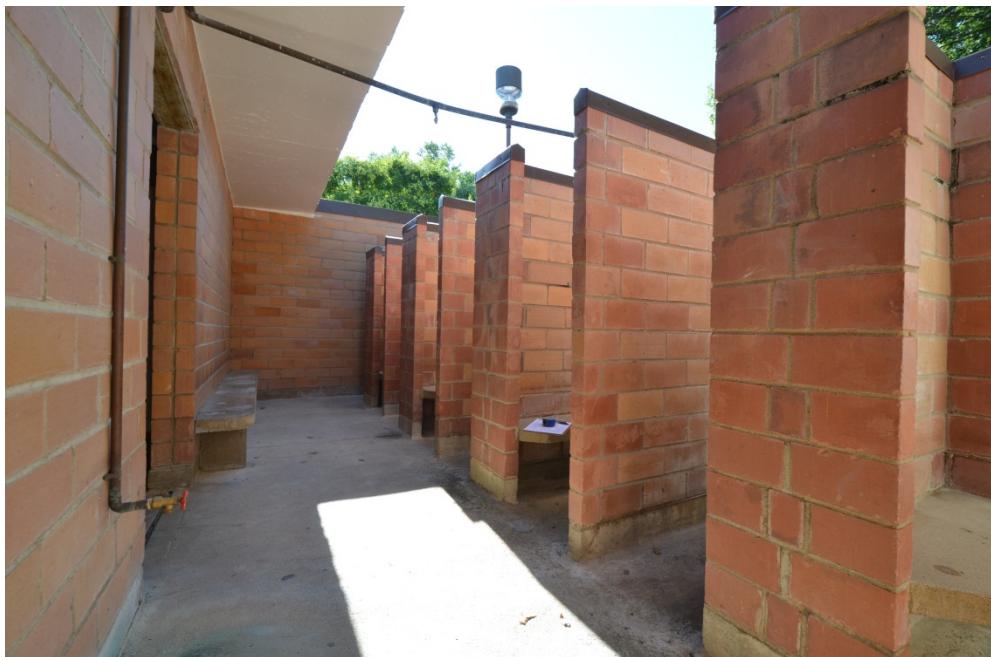
The structural stability of the single wythe clay masonry partitions that are unsupported at the top present a significant safety concern. It is not known if these walls are reinforced, but it should be noted that it would be difficult to achieve the code required lateral resistance with new reinforced masonry walls of similar thickness that are unsupported at the top.

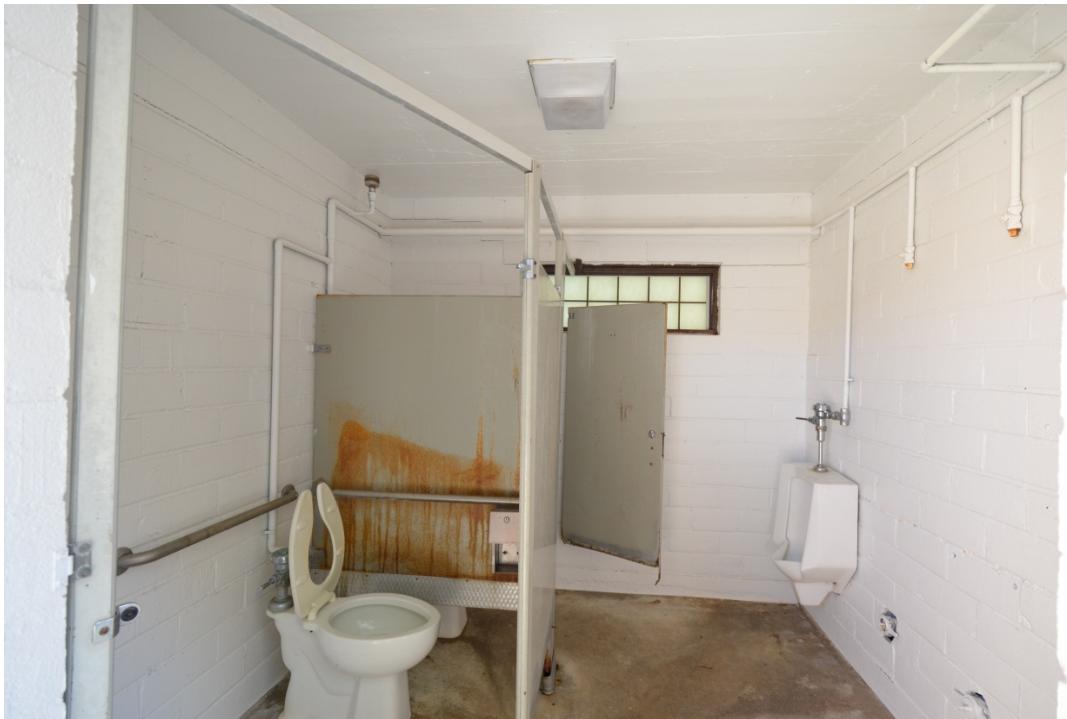
Toilet and shower facilities do not conform to ADA accessibility requirements in size, clearance, arrangement or fixture type.

Accessible maneuvering space is achieved in the male gender restroom by eliminating a toilet partition and door and presenting the toilet open to the dressing area.

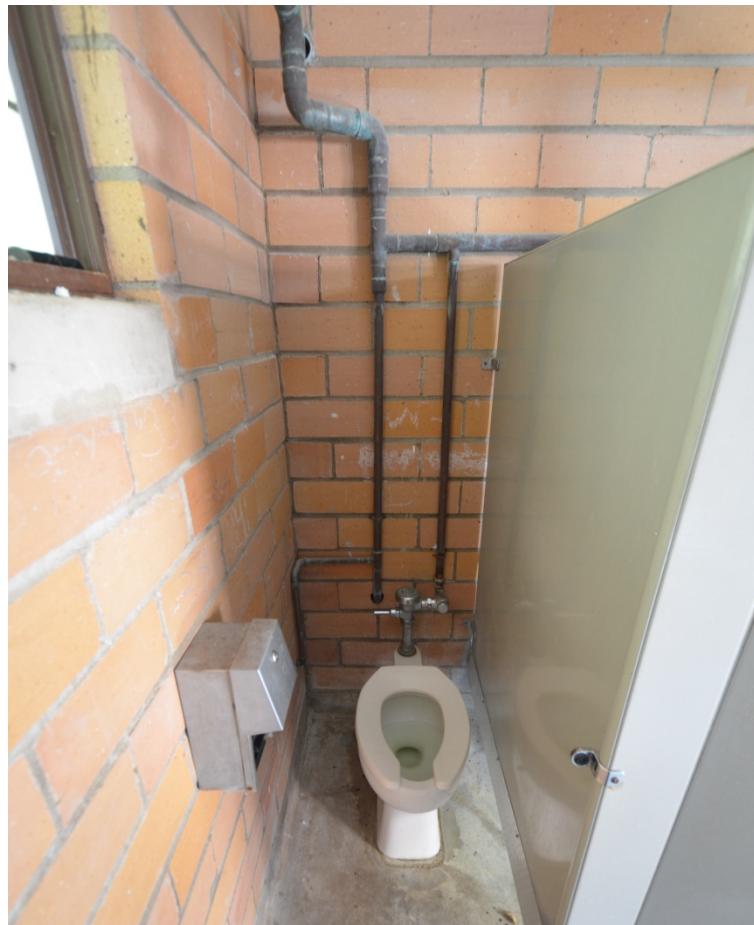
Plumbing fixture and exposed piping upgrades have been made in years past. The plumbing system is still serviceable, but is aging and will need to be replaced in time.

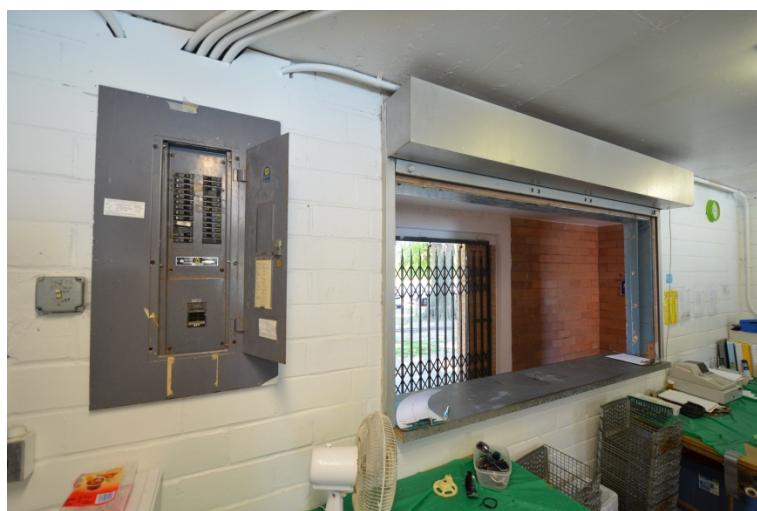
The electrical power distribution and lighting systems have been upgraded in years past, but are aging and will need to be replaced in time.

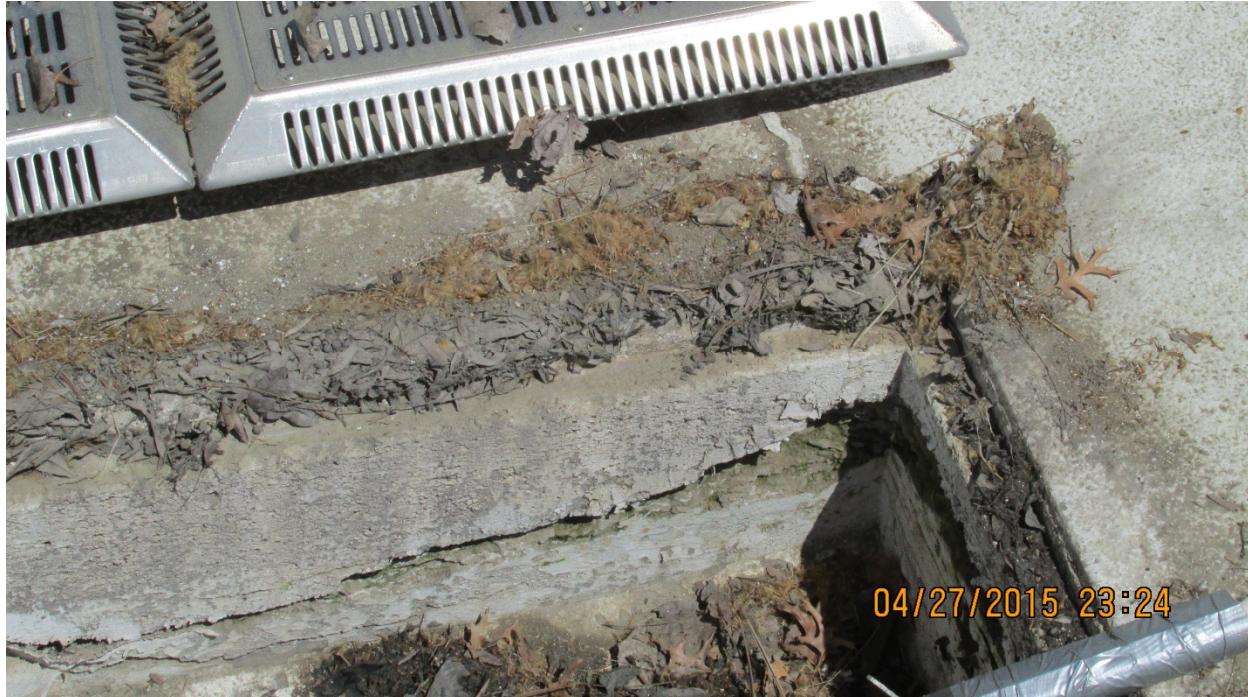
**Main Drain Structure**

2. Main Drain Structure & Piping - The main drain structure has severe cracking and deterioration. With the cracking and deterioration of the structure, it is a possibility that water is leaking out of the pool and could have caused the void on the south side of the main drain.

During our inspection, the City of Fairbury's Utility Department ran a camera through the main drain to look at the pipe condition. After viewing the inspection, the main drain system piping was in fair condition. The pipe did have some scaling and buildup on the walls but the joints appeared to be tight and not leaking. There is also some debris throughout the line but could be cleaned by jetting. This area of the piping is the original piping installed in 1952.

The diving well of the pool basin is in need of replacement due to the water loss through the cracks in the main drain structure, poor concrete testing, and possible voids under the concrete floor. Temporary patching of the main drain structure could extend the life of the basin but should not be used as a permanent fix. In order to continue to host competitive swimming events, the pool depth needs to be increased to meet the YMCA diving standards. The current standards for competitive swimming require the shallow end of the pool to be at least 5 feet deep for YMCA regulations and 7 feet deep for NCAA regulations. To get to the minimum depth, the pool deck would need to be raised at least 2 feet. The deck is in good condition but would need to be removed in its entirety to allow the pool basin wall height to be extended to meet depth requirements for competitive swimming. The wading and kiddie pools are in good condition structurally. The circulation system needs upgraded. Installation of a new stainless steel gutter system is recommended. The filter system, recirculation system, and chemical treatment system all operate as originally designed in 1952 and 1990, but requires manual handling of chemicals and manual testing. A new chemical system is required to meet current standards. The current standards for the recirculation rates are:

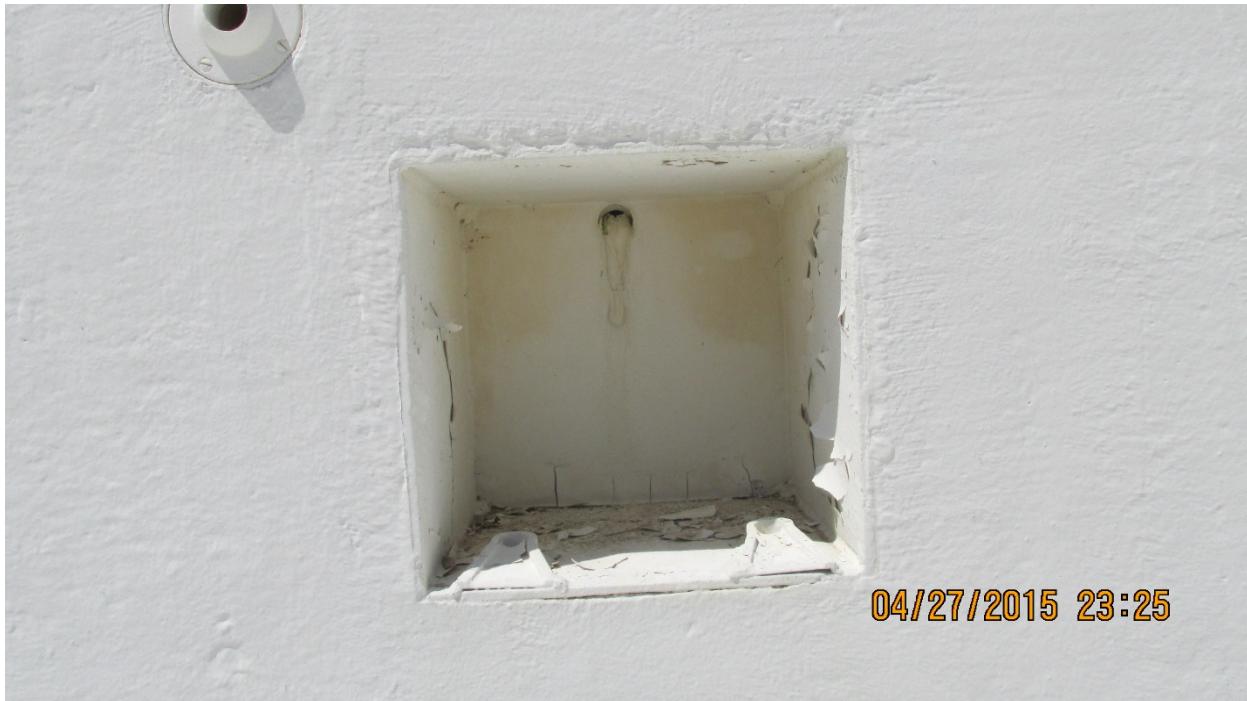
**Abandoned Underwater Light Boxes**

3. Lighting – The original pool design included both underwater and overhead lighting for night swimming. The underwater lighting was abandoned during the pool remodel in 1990. The abandoned underwater light boxes had open conduits which currently are not in service and could have been a source of water leaking from the pool. Before the 2015 swimming season, the City staff placed caulking in the open conduit to mitigate potential leaking.

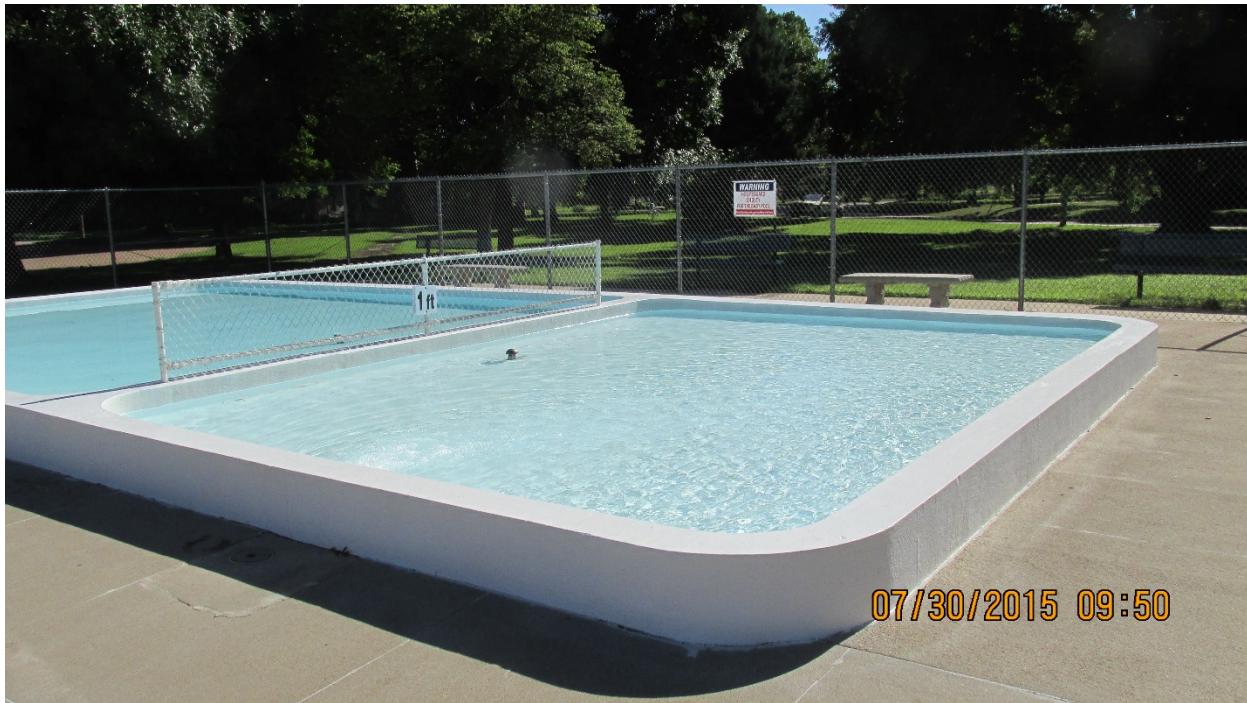
- a. Wading Pool – The concrete wading pool appears to be in good condition and only shows minor hairline cracks. The primary concern with the wading pool is the circulation system which will be discussed later in this report.
- b. Kiddie Pool – The concrete kiddie pool appears to be in good condition and only shows minor hairline cracks. The primary concern with the kiddie pool is the circulation system which will be discussed later in this report.

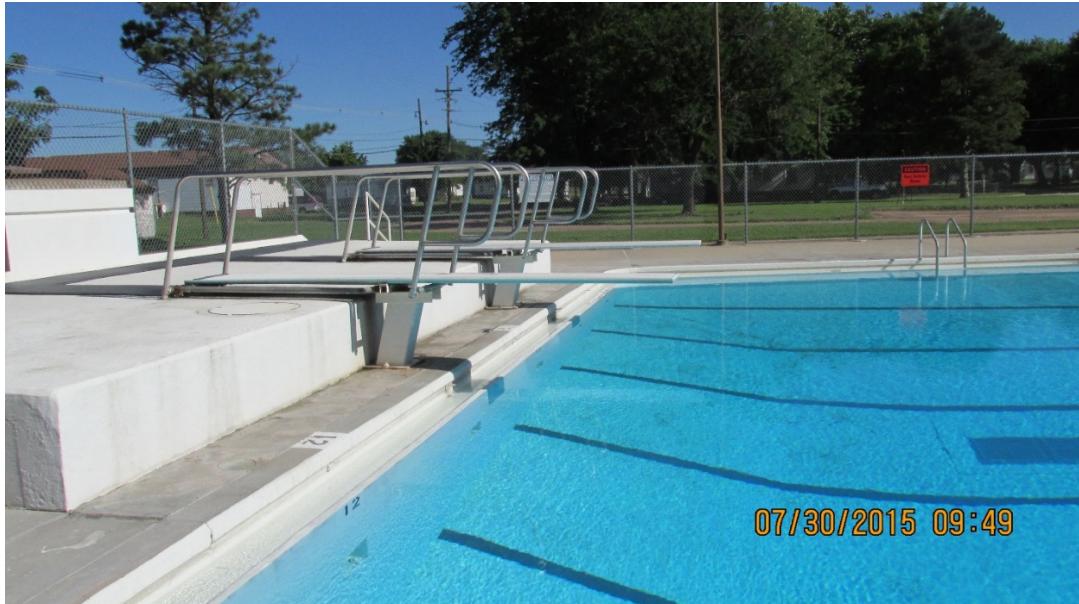
9. Diving Boards – The diving boards are 1 meter boards and are in fair condition and meet current standards. Whether a new pool basin is constructed or the existing pool basin is refurbished, these boards could be reused.

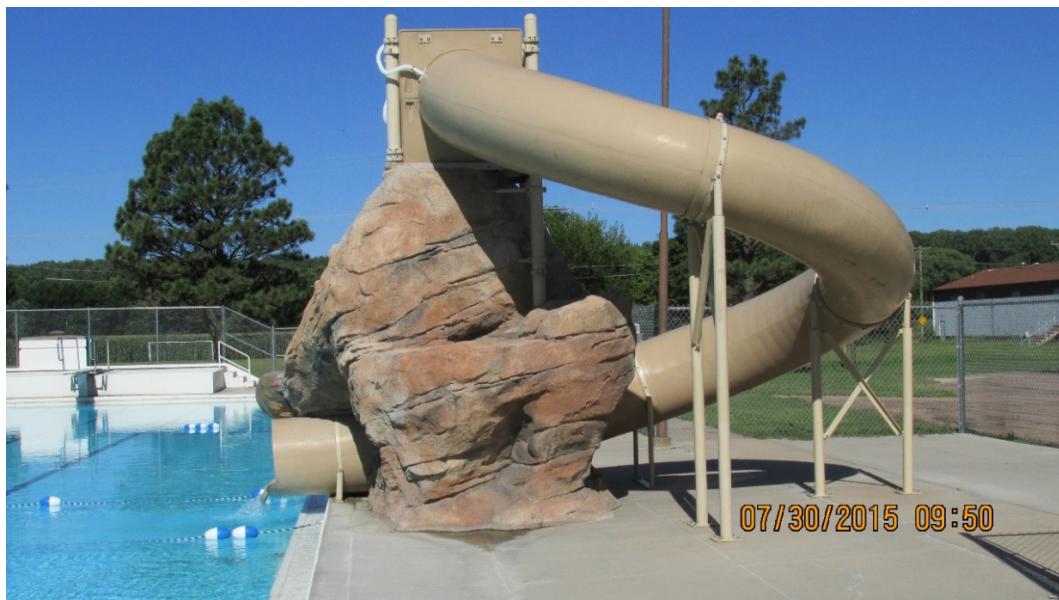
10. Slide – The existing slide is fairly new and in good condition. If the existing pool was to be updated, the current slide could be reused. If a new pool basin was constructed, the slide could potentially be reused depending on the new pool layout.

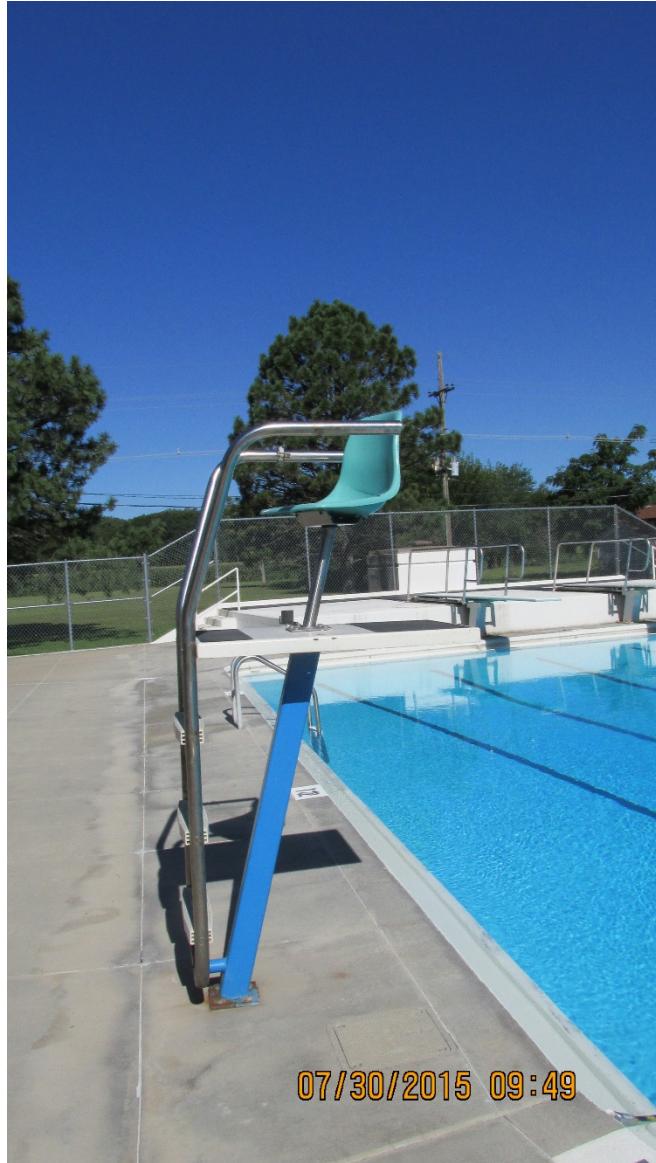
11. Lifeguard Chairs – There are currently 4 lifeguard chairs around the pool basin. The lifeguard chairs are in fair condition. They are placed in the appropriate locations so that the lifeguards are able to maintain surveillance of all pool floor areas.

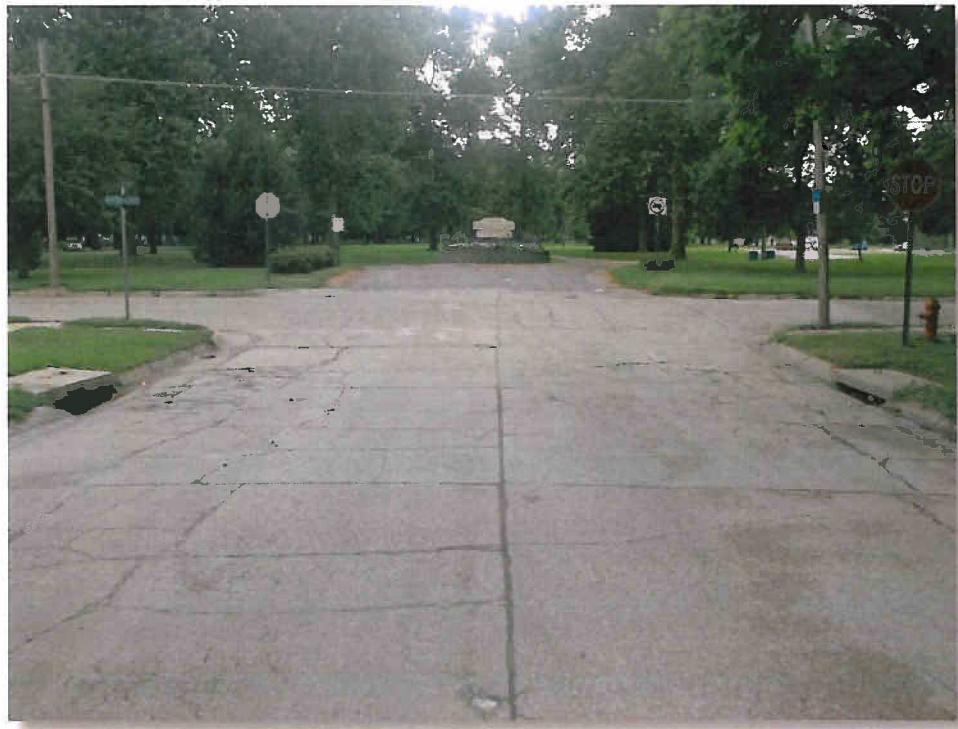
**Photo 5.5** View looking south at the city park entrance on W. 8<sup>th</sup> Street and Maple Street. Two existing inlets on Maple Street completely filled with debris.

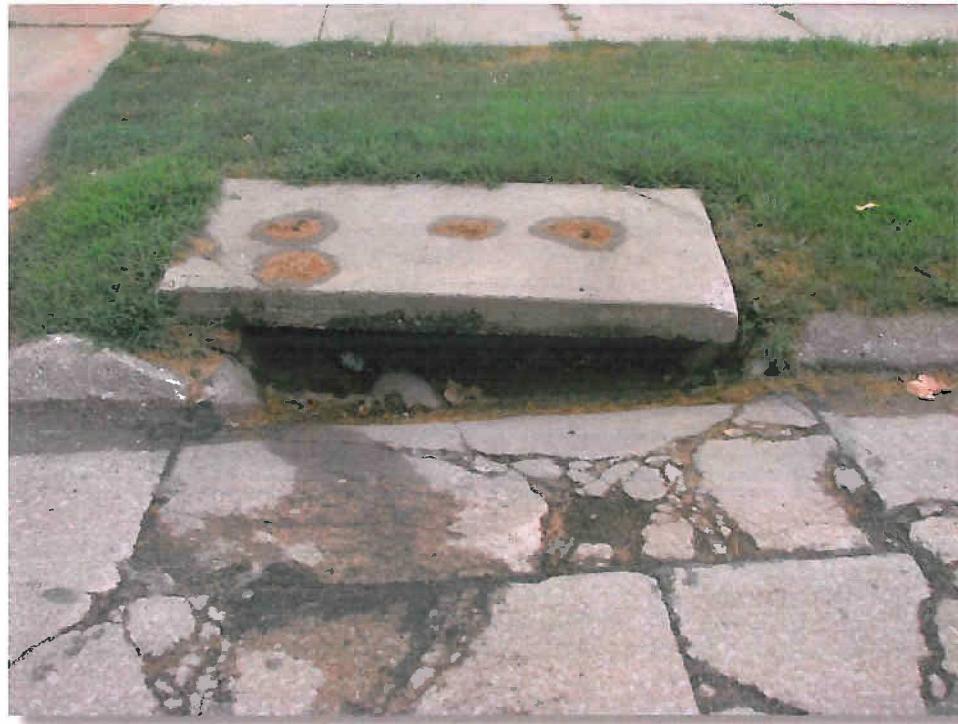
**Photo 5.6** View of inlet on east side just north of W. 8<sup>th</sup> and Maple Street. Debris has collected in the inlet. Inlet connects to storm sewer system on west side of City Park.

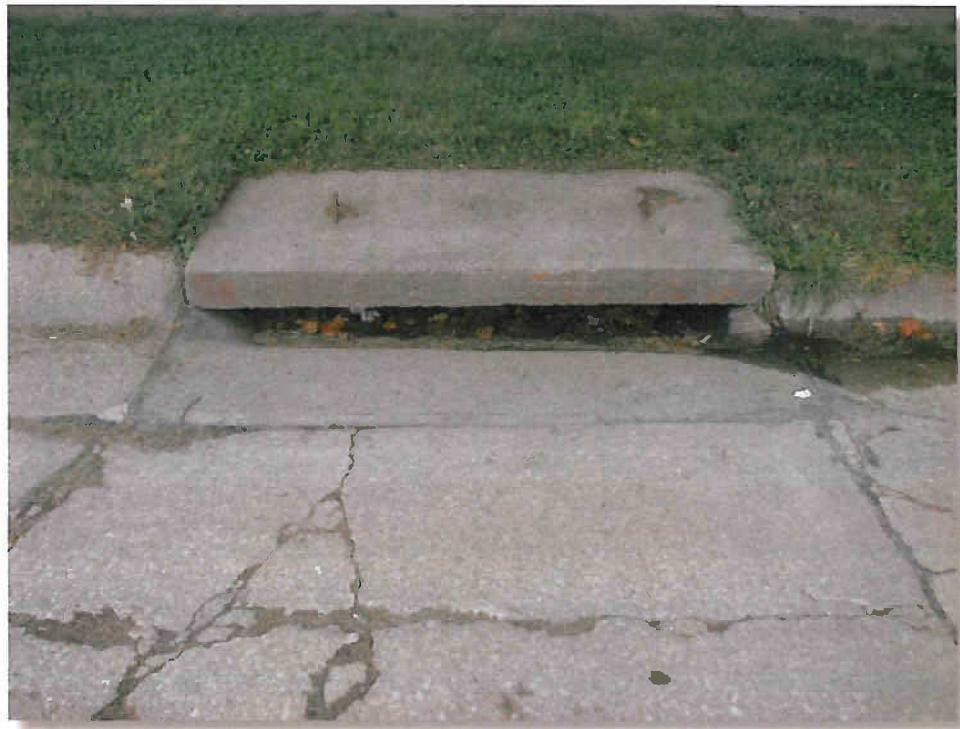
**Photo 5.7** View of inlet on west side just north of W. 8<sup>th</sup> and Maple Street. Debris has collected in the inlet. Inlet connects to storm sewer system on west side of City Park.

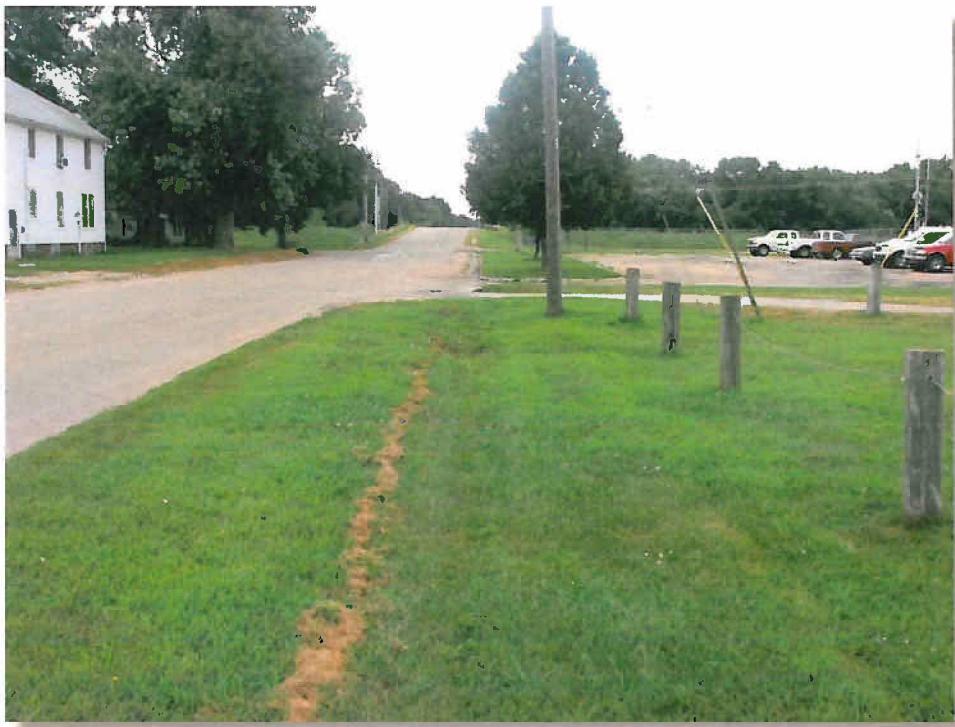
**Photo 5.13** View looking south on Fredrick Street on the west side. Drainage ditch and existing inlet shown toward the drive. Inlet covered in grass.

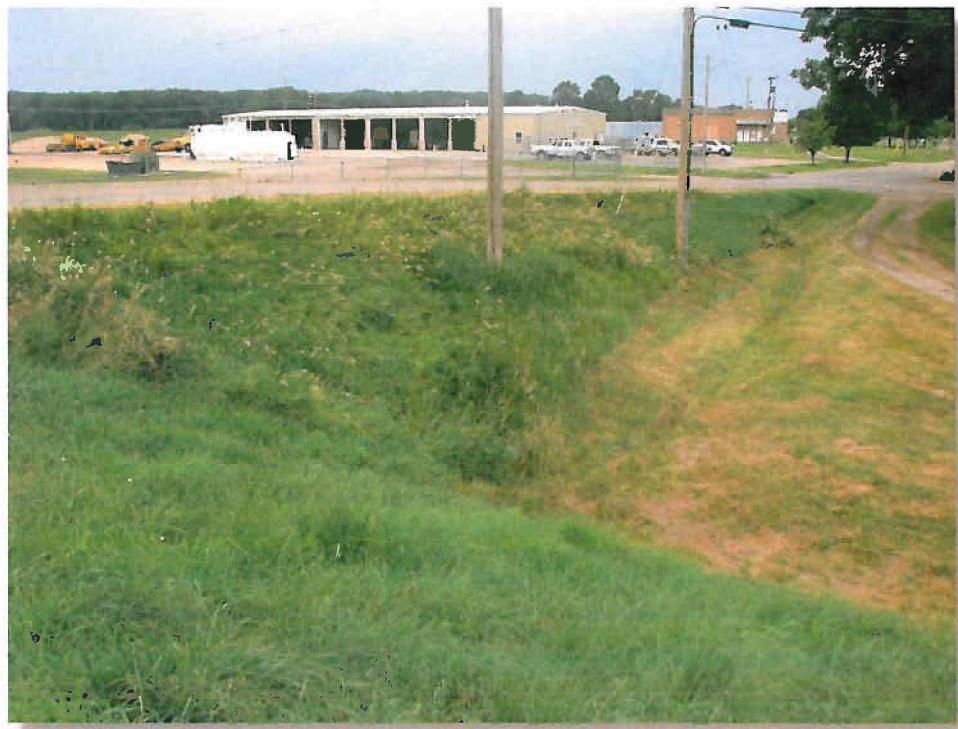
**Photo 5.19** View looking north from top of levee on east side of Fredrick Street.  
Existing 24 inch culvert at toe of levee covered by vegetation.  
Connects to inlet on west side of Fredrick Street.
