RE: Fairbury Asbestos Inspection Report

Property of Randy Griffin

321 W 3<sup>rd</sup> Street

## Building Asbestos Inspection Report

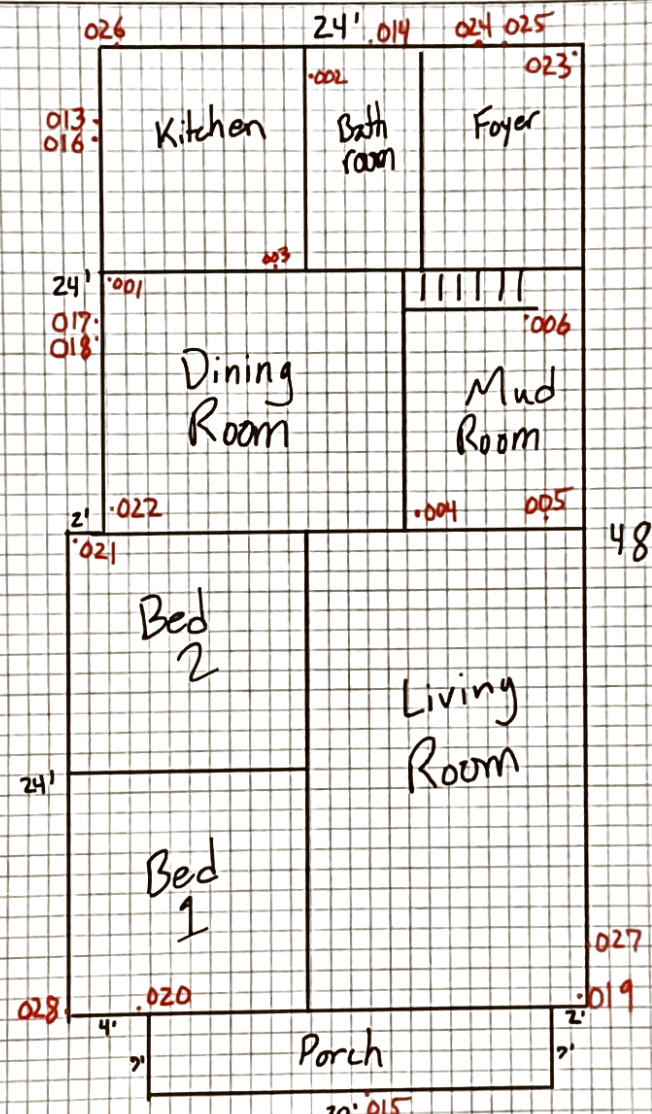
### Sample Locations (Main Floor)

026 24' 014 024 025  
013 016 Kitchen Bath room Foyer 023  
24' 001 003  
017 018 Dining Room Mud Room 006  
2' 022 004 005 48'  
021 Bed 2 Living Room  
24' Bed 1  
028 020 027 019  
4' 7' Porch 2' 7'  
20' 015
