RE: Fairbury Asbestos Inspection Report

Property of Tammy Reynolds
408 A Street
Fairbury, NE 68352
40.135475° N, 97.185091° W

Building Asbestos Inspection Report

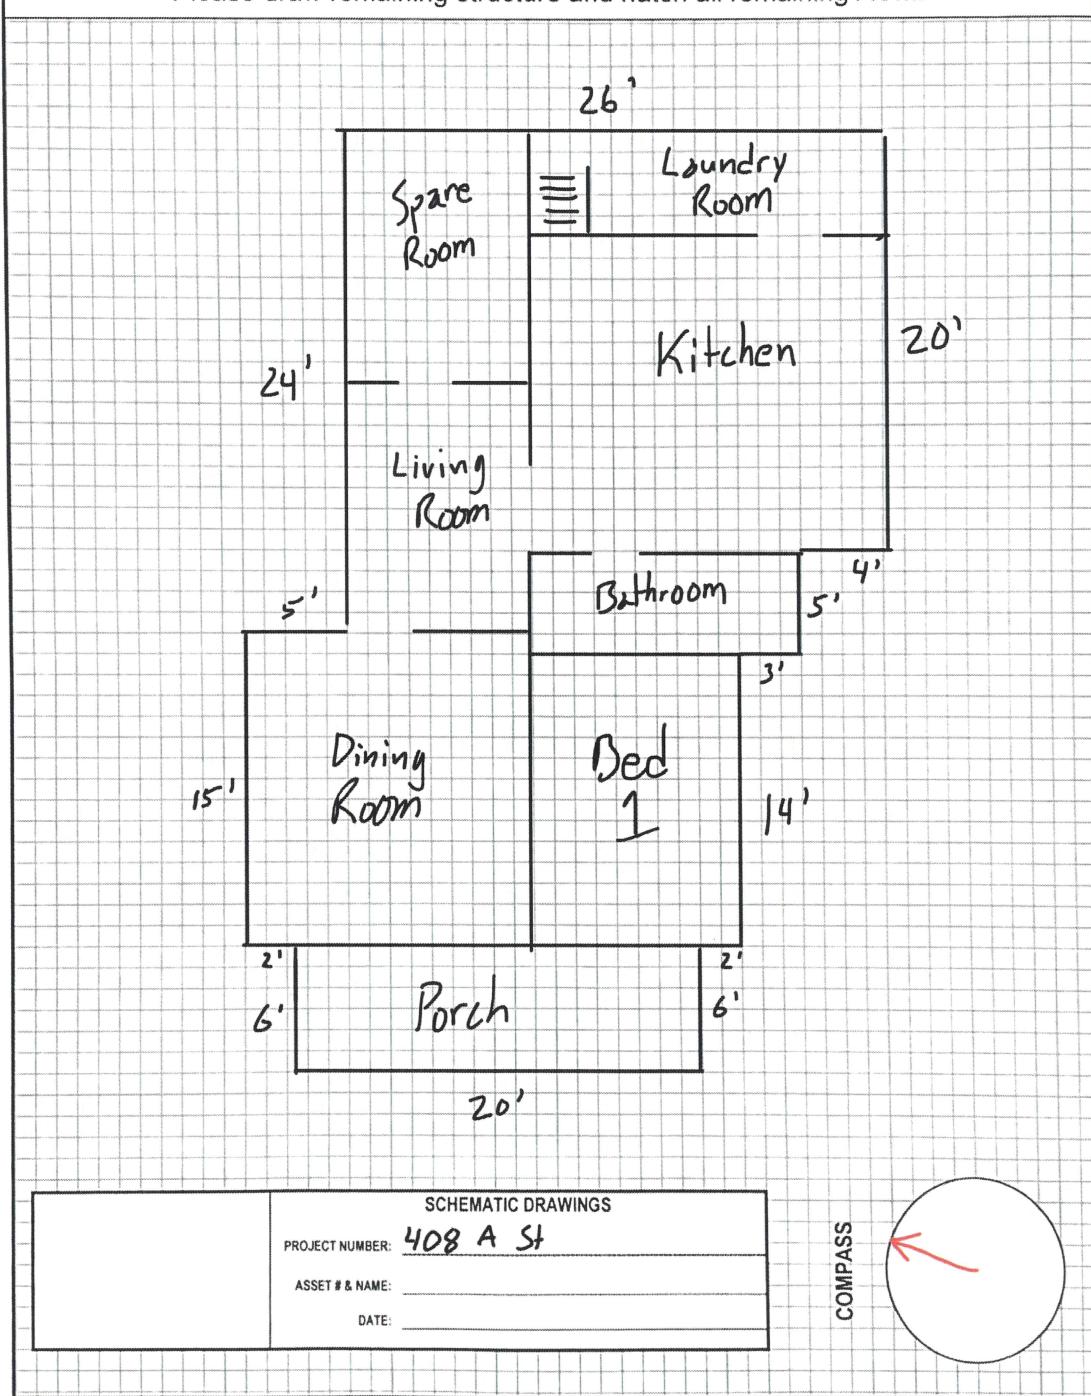
Sample Locations

Sample Date	Sample ID	Description	Location	Asbestos Result ²	Asbestos Type	ACM Category	Friable Y/N	Quantity
2/09/2023	FAI-408-090223-001, 002, 003	White Duct Insulation	Interior, Ducts in basement	75%	Chrysotile	RACM	N	30 sf
