# PARK & POOL STUDY

PREPARED FOR  
**CITY OF FAIRBURY**  
—  
**FAIRBURY, NEBRASKA**

**MAY 5<sup>TH</sup> 2016**

**OA PROJECT No. 015-2112**

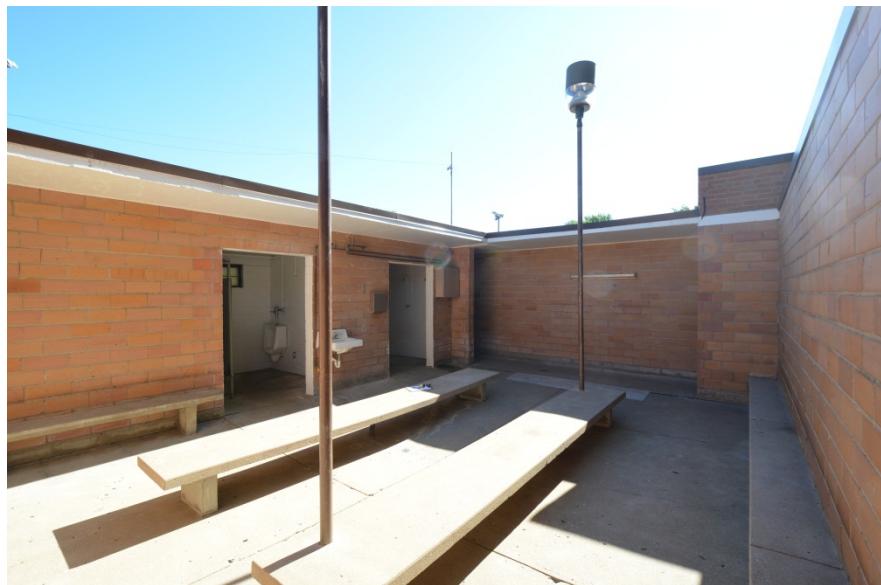
The dressing areas are open to the sky which raises the concern about visual privacy and is an open invitation for trespassing and vandalism. While this is not a structural issue it is recognized that a roof structure will need to be added over the dressing areas if the existing bathhouse were to be saved and renovated.

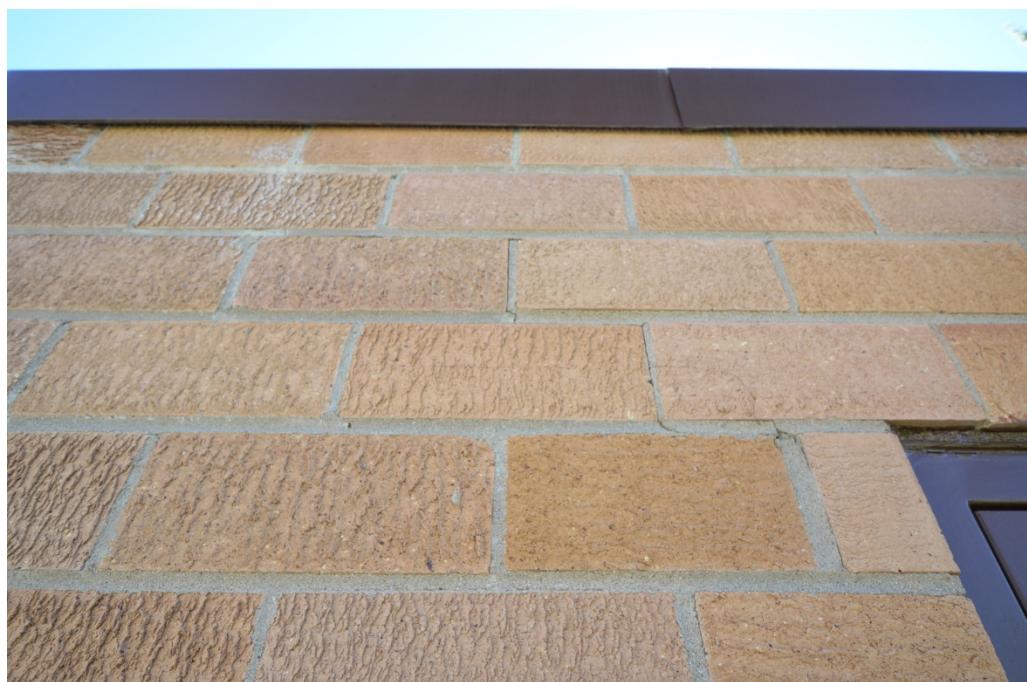
Slight foundation settlement has occurred at the southwest corner as indicated by the stepped diagonal crack in the masonry mortar joints.

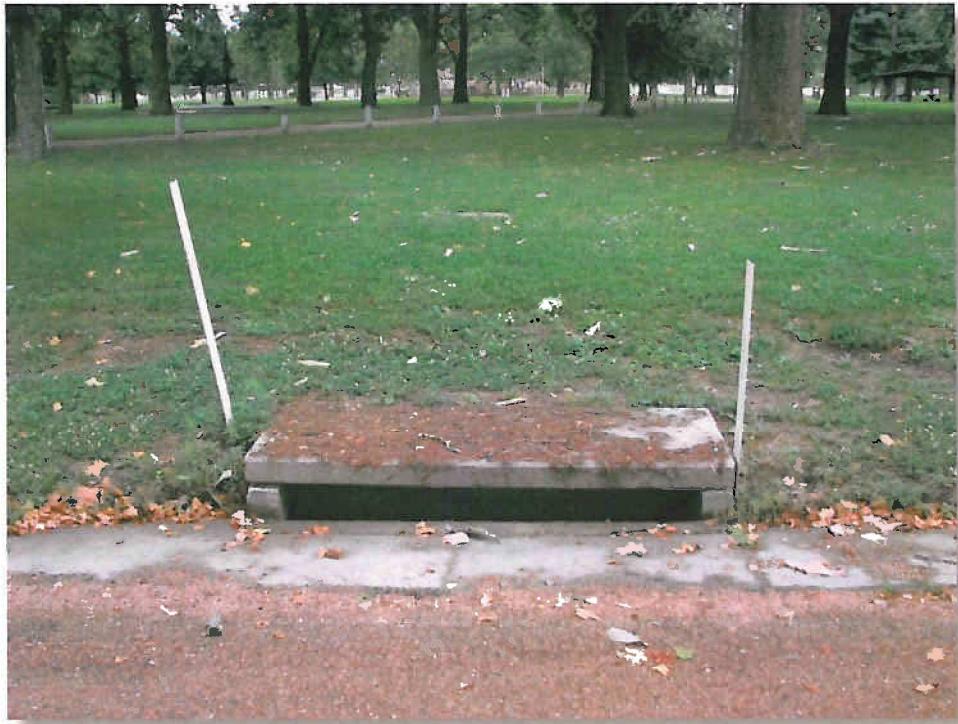
**Photo 5.1** Existing inlet at the southeast corner of Park Road at the city park looking west.

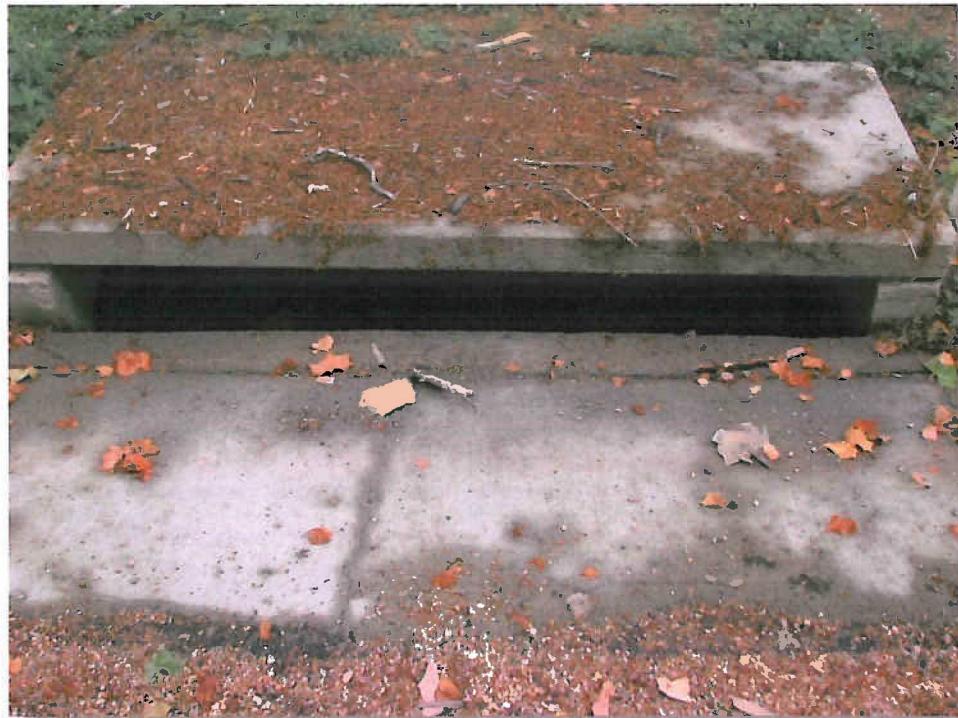
**Photo 5.2** Existing inlet at the southeast corner of Park Road at the city park.

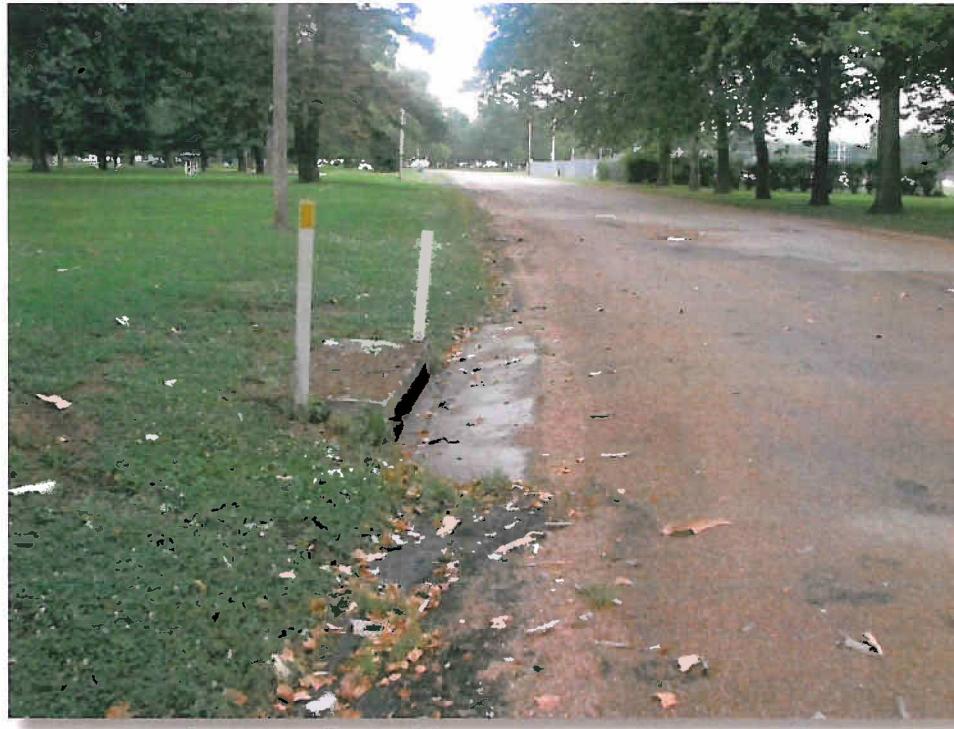
**Photo 5.3** View looking north from existing inlet at southeast part of the city park.

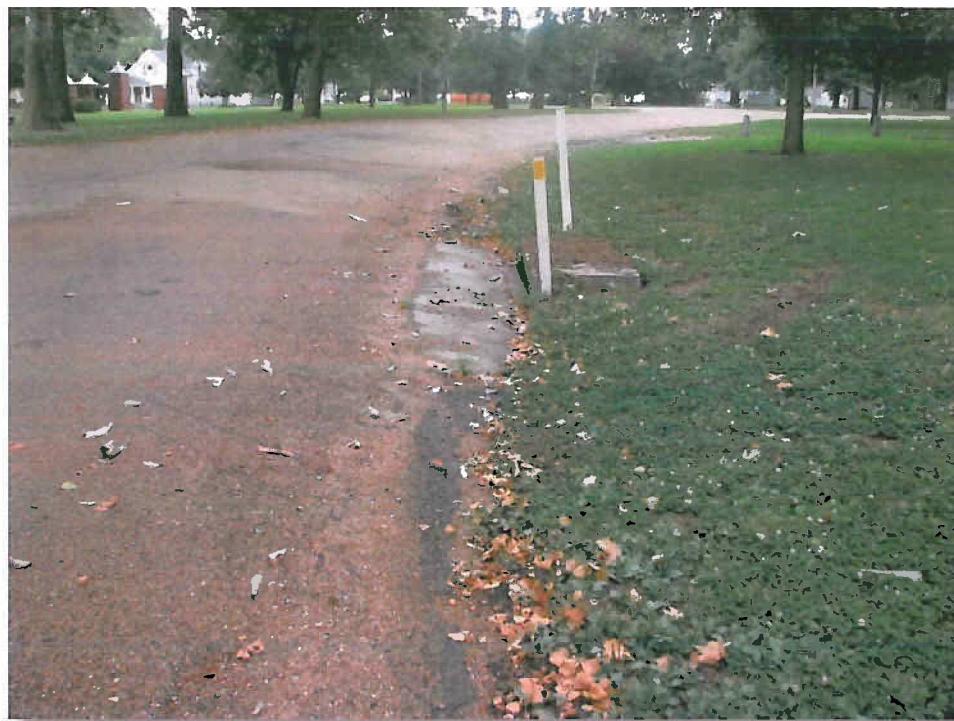
**Photo 5.4** View looking south from existing inlet at southeast part of the city park.

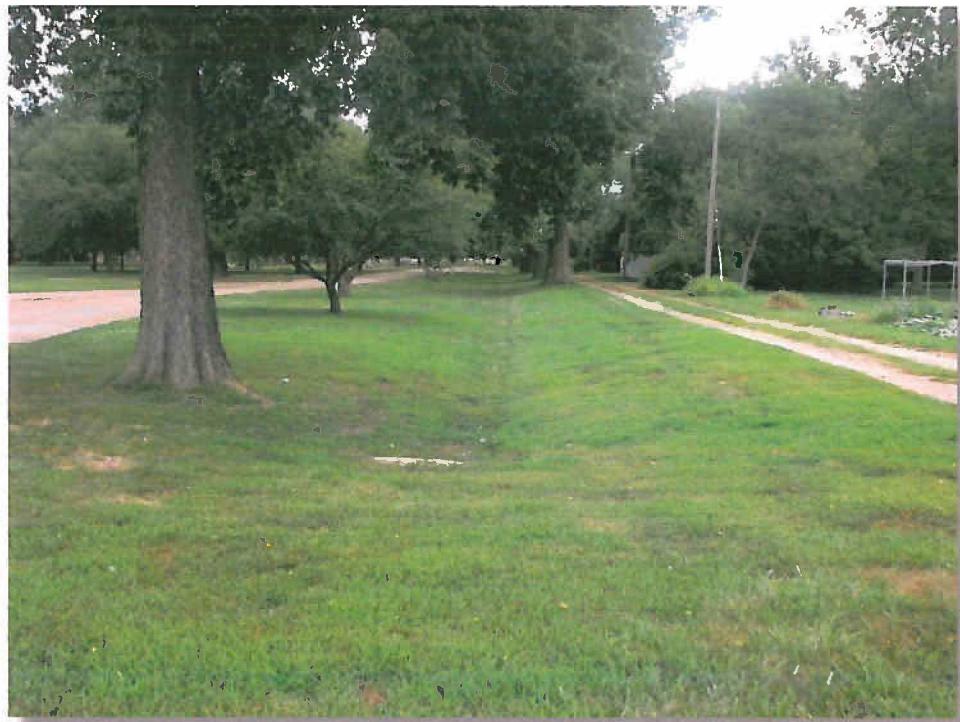
**Photo 5.8** View looking east at south end of city park near the RV dumping station. Drainage swale collects runoff from the east and enters inlet as shown.

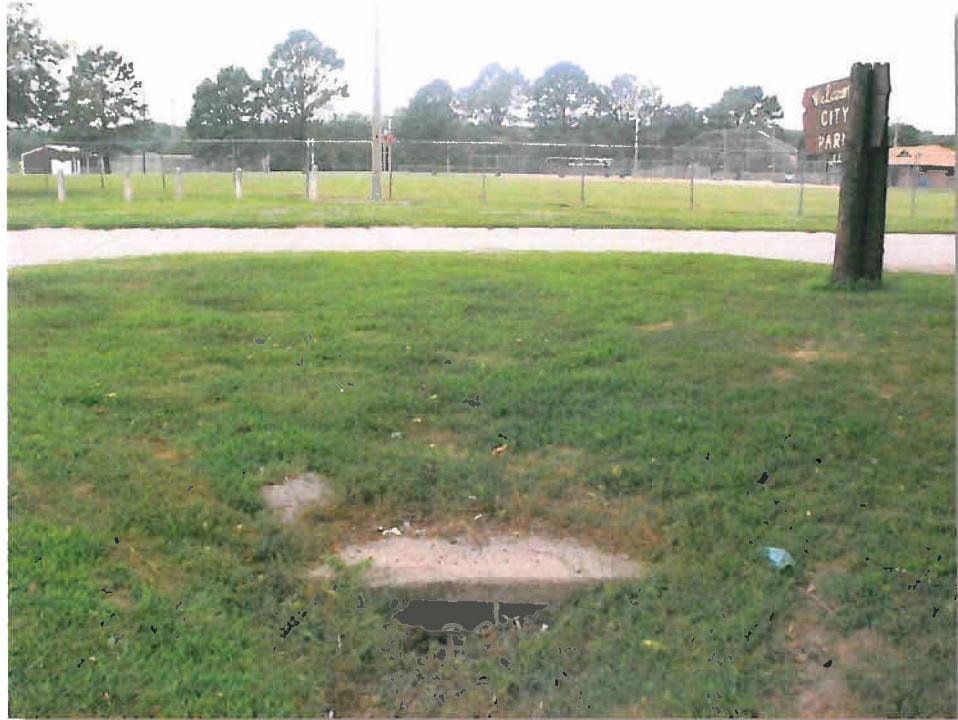
**Photo 5.9** View looking west at inlet by the RV dumping station on the southwest side of the city park. Inlet collects runoff and ties into the storm sewer system on the west side of Fredrick Street.

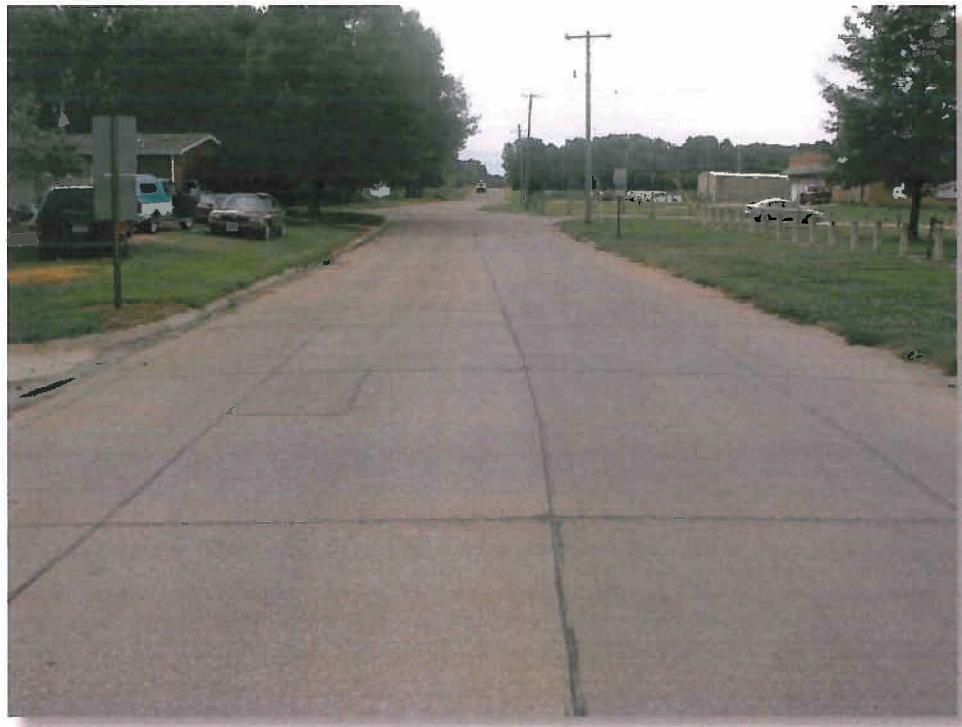
**Photo 5.10** View looking south on Fredrick Street toward the levee south of town. Existing storm sewer system on the west side of Fredrick Street which discharges into the Little Blue River.

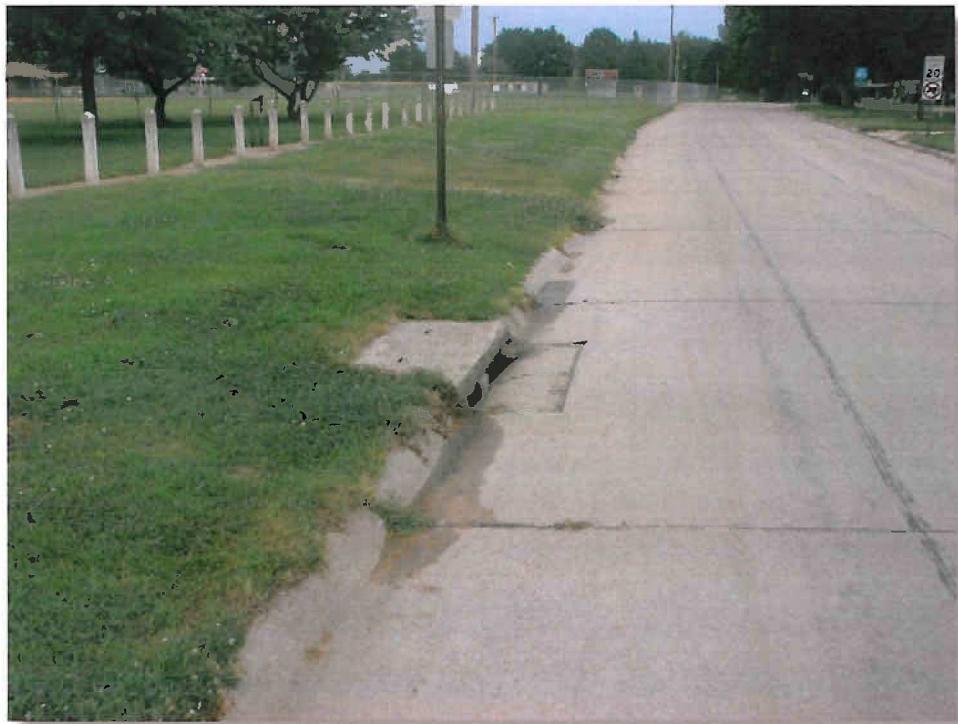
**Photo 5.11** View looking north on Fredrick Street just north of W. 4<sup>th</sup> Street. Existing curb inlet on the west side collects runoff into the system which discharges into the Little Blue River.

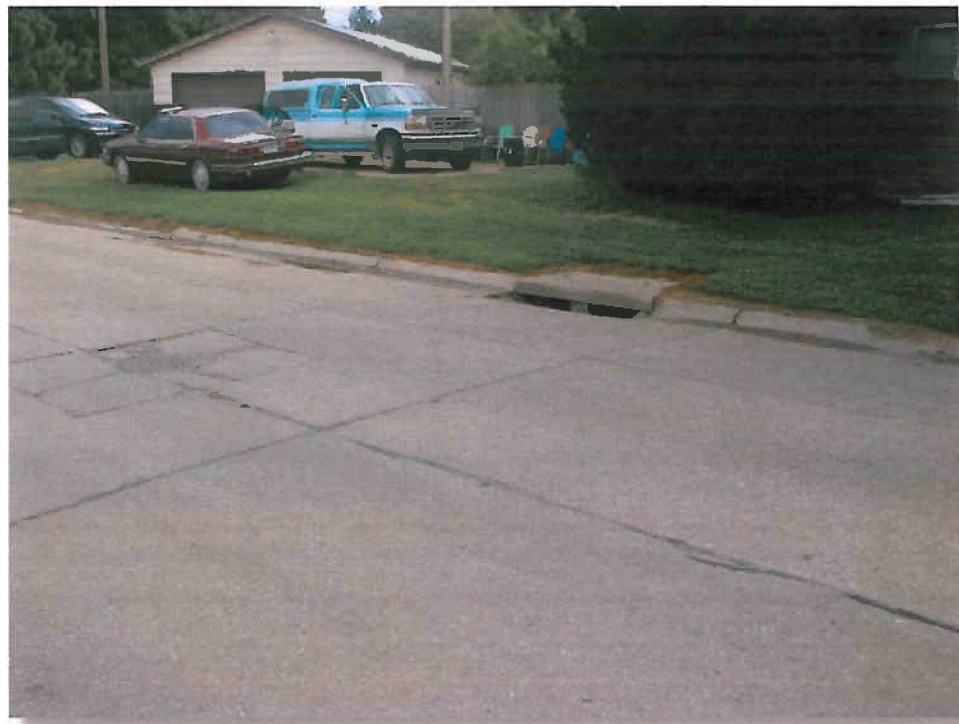
**Photo 5.12** View looking north on Fredrick Street just north of W. 4<sup>th</sup> Street. Existing curb inlet on the east side collects runoff into the system which discharges into the Little Blue River.

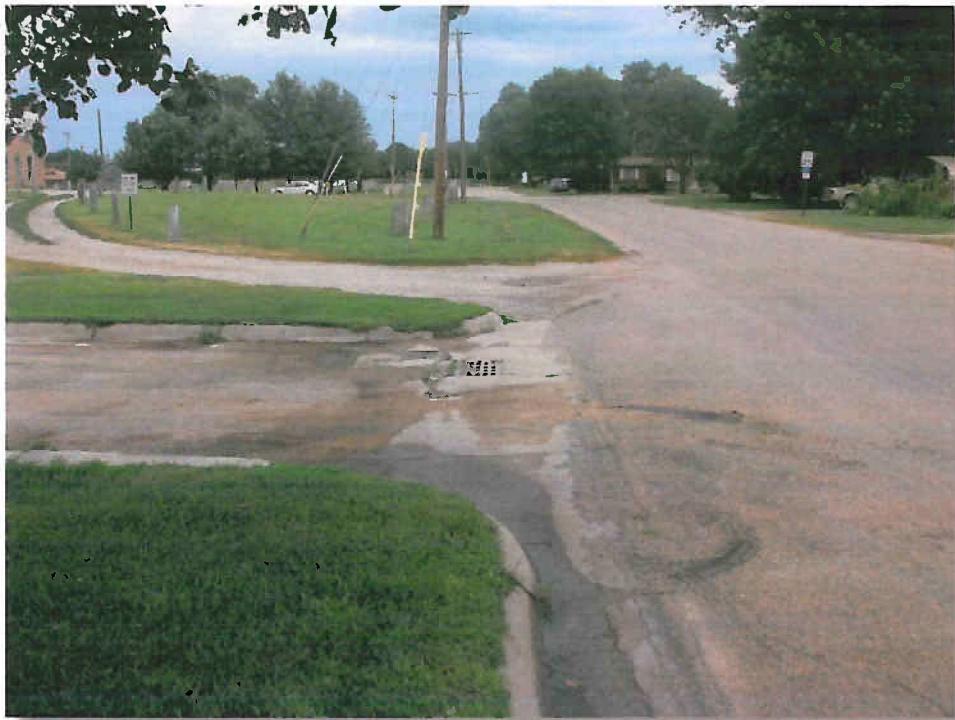
**Photo 5.14** View looking north on Fredrick Street on the west side at entrance drive of maintenance building. Inlet appeared to be free of debris. Connects to storm sewer which discharges into the Little Blue.

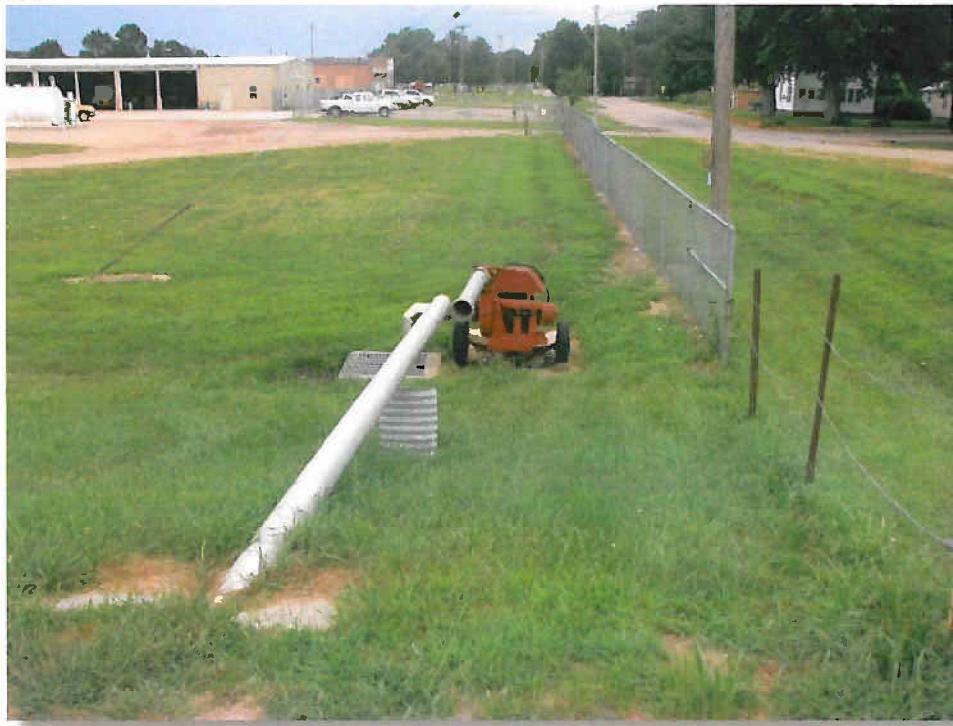
**Photo 5.15** View looking north from the levee toward maintenance building on west side of Fredrick Street. Inlet with weir type structure collects runoff from the west and north.

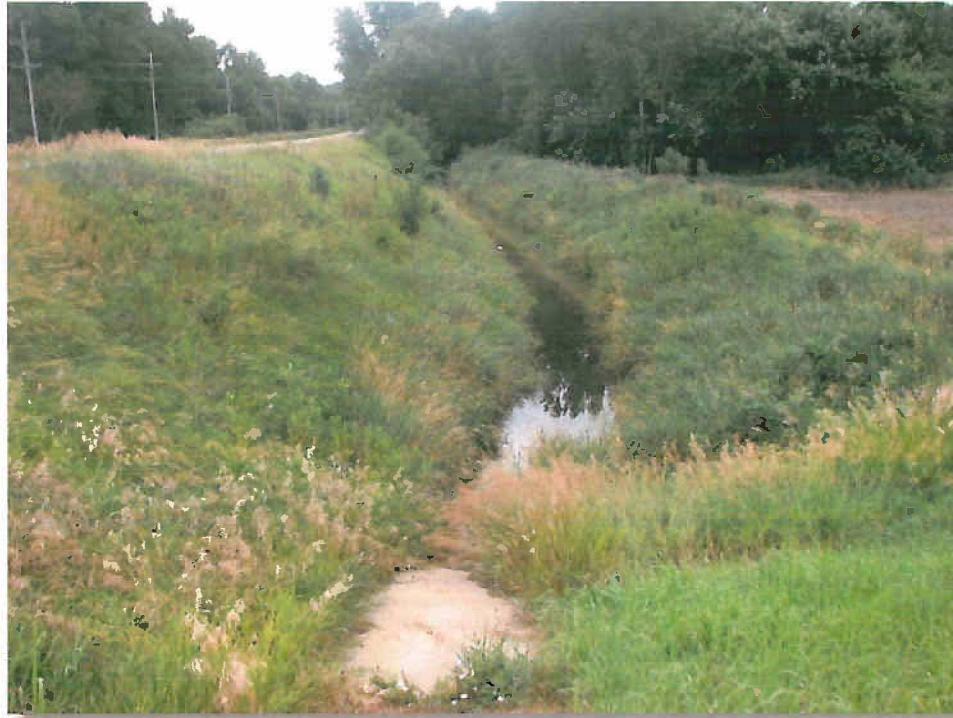
**Photo 5.16** View looking south from top of levee where city park storm sewer on west side of Fredrick Street discharges into the Little Blue. Existing 36 inch culvert with flap gate.

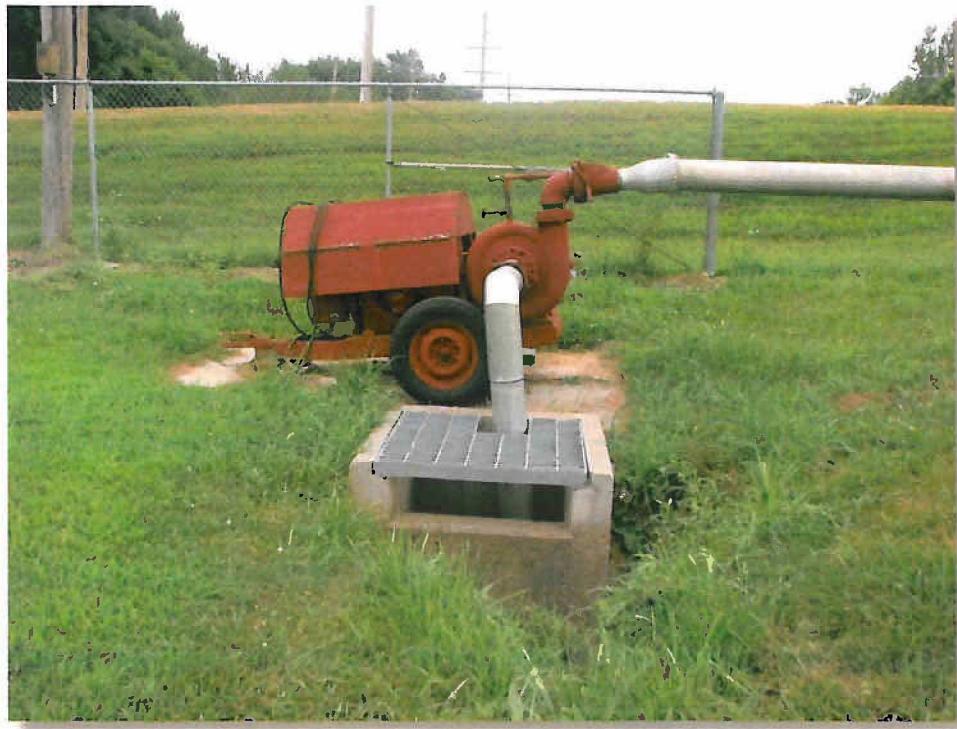
**Photo 5.17** View looking west at inlet with weir structure on north side of levee west of Fredrick Street.

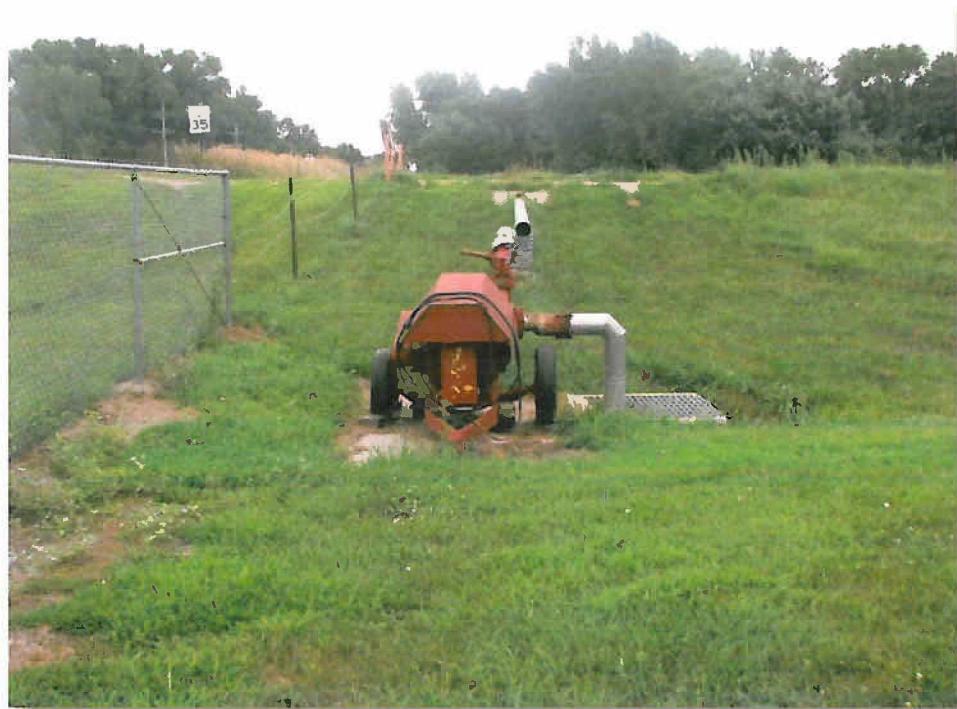
**Photo 5.18** View looking south at inlet with weir structure on north side of levee west of Fredrick Street.

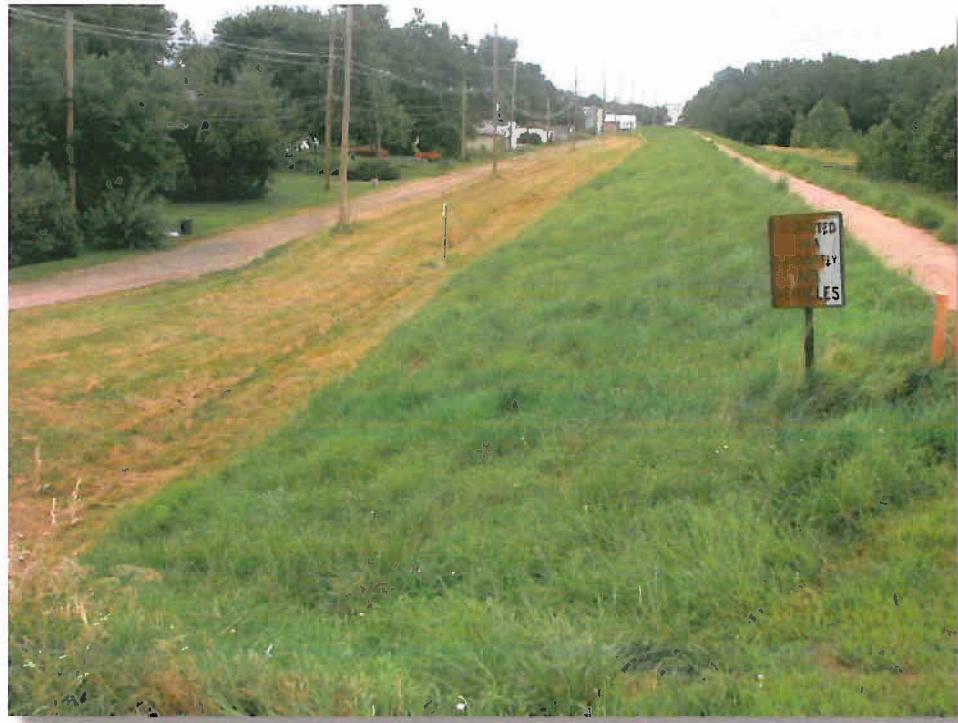
**Photo 5.20** View looking east from top of levee on Fredrick Street.
